# Willow Brook Flood Mitigation Study

East Hartford, Connecticut

August 2016

MMI #2854-37-5

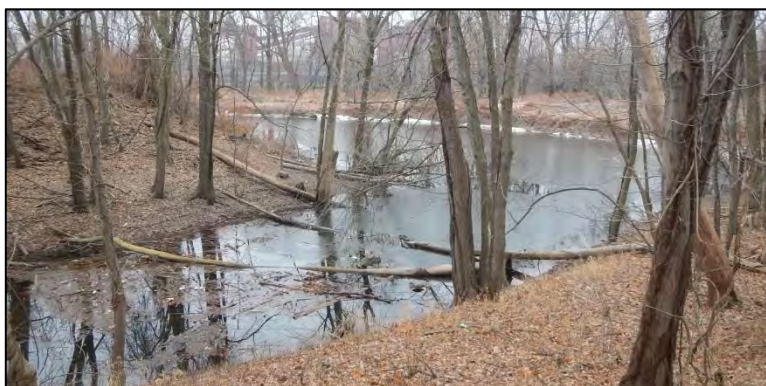
Reach #1 is a particularly flat stream segment that is heavily influenced by the Connecticut River. Tidal fluctuations from Long Island Sound extend upstream to the Hartford area, with typical tidal ranges between 0.5 and 1 foot. Higher river stages in the Connecticut River cause a backwater into Willow Brook as far as the downstream end of the Route 2 culvert, or about 2,000 feet upstream of the confluence of Willow Brook with the Connecticut River. This channel

*Reach # 1 Connecticut River to Route 2 Culvert*

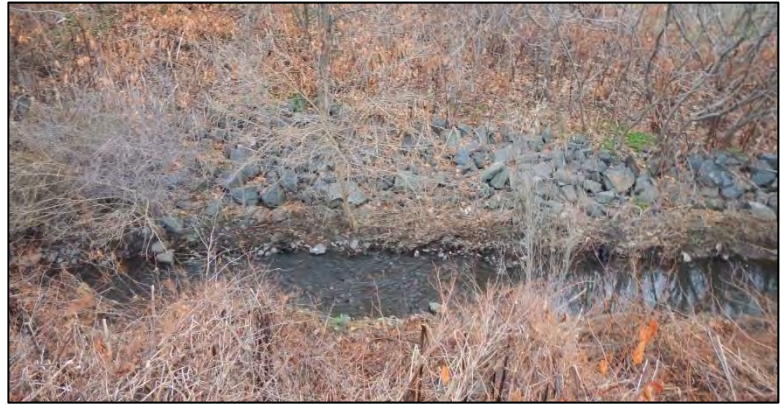
The channel upstream of Route 2 inclusive of the Main Street Bridge is highly entrenched, with steep (1:1), tall vegetated banks and no associated floodplain. These steep banks appear to have been created by placing fill in the floodplain, likely over many decades, to accommodate development in the surrounding areas. The channel slope in this reach averages 0.7%, making it one of the steeper reaches of the brook. Channel bed substrate in this area is characterized by a sandy gravel mix with cobbles and placed riprap, likely placed to protect against higher flood velocities.

*Reach #2 Route 2 Culvert to Pratt & Whitney Dam*

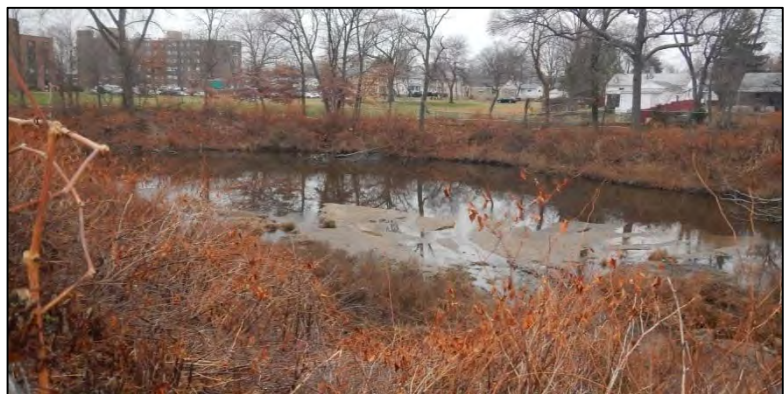
The Pratt & Whitney dam is located at the downstream end of Reach #3. The dam is a concrete structure that was originally constructed to impound water and create a small pond. Historically, the impounded water reportedly provided cooling and process water for the Pratt & Whitney production facility. Upstream of the dam, the small (550 feet long by 150 feet wide) pond has begun to fill with sediment, with invasive vegetation beginning to grow along the banks and atop sediment bars. The upstream end of this reach includes a small section of 108-inch RCP culvert that supports a small grassed path that does not appear to be in active use.

*Reach #3 Pratt & Whitney Dam to Pratt & Whitney Conduit*

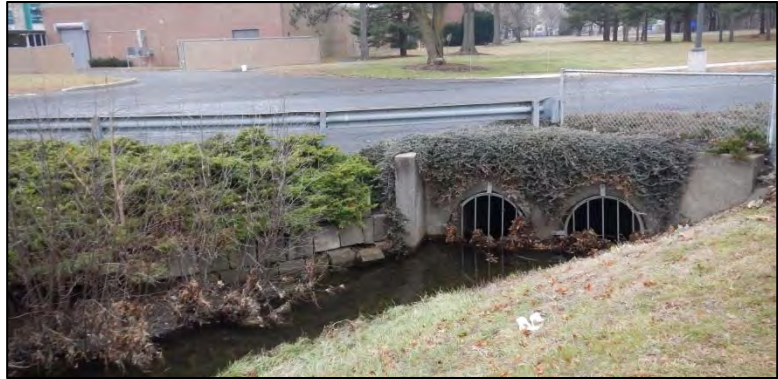
Reach #4 is comprised of a 3,475 foot long conduit that contains Willow Brook beneath the Pratt & Whitney facility. The enclosed brook flows southwesterly from the Silver Lane entrance to Pratt & Whitney, to its discharge point above the impoundment (described in Reach #3). Based on historic aerial photographs, the conduit appears to have been constructed in stages as the Pratt & Whitney campus was expanded. Records of the varying pipe sizes and types are sparse, and direct observation of the culvert is difficult due to physical constraints. More detail about this conduit is provided in Section 2.12.3.

*Reach #4 Pratt & Whitney Conduit (Upstream Entrance)*

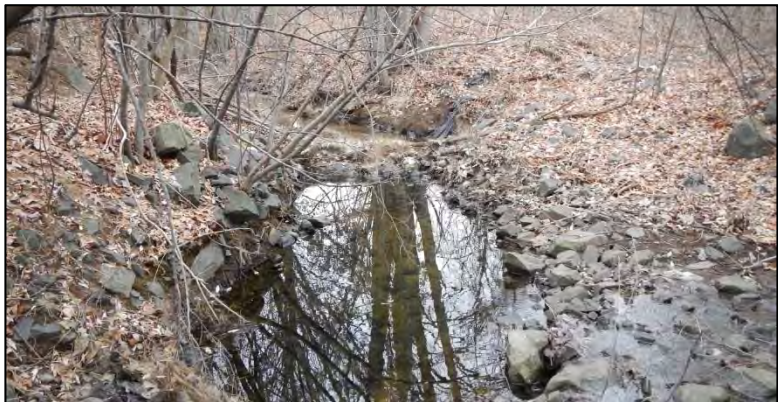
Upstream of the Pratt & Whitney conduit, the Willow Brook channel flows beneath the Rentschler Field access drive and through an overflow parking area that is located adjacent to athletic fields and residential homes. This reach of channel is more naturalized than many other segments of Willow Brook, and is bordered by a vegetative buffer on both banks. Substrate in this reach is characterized by a silty sand bed. The reach slope is 0.26%.

*Reach #5 Pratt & Whitney Conduit to Simmons Road Culvert*

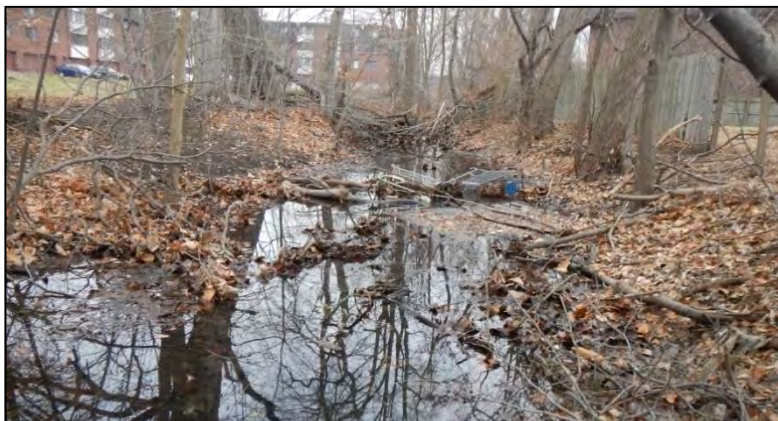
*Reach #6 Simmons Road to Hockanum River Diversion*

Reach #6 has a silty bottom, and is subject to organic and manmade debris accumulation. Silt, leaves, and woody debris buildup has occurred over time as well, likely due to reduced flows in the channel caused by a diversion structure immediately upstream (described in Reach #7 narrative), combined with the shallow slope to create extremely low flow velocities.

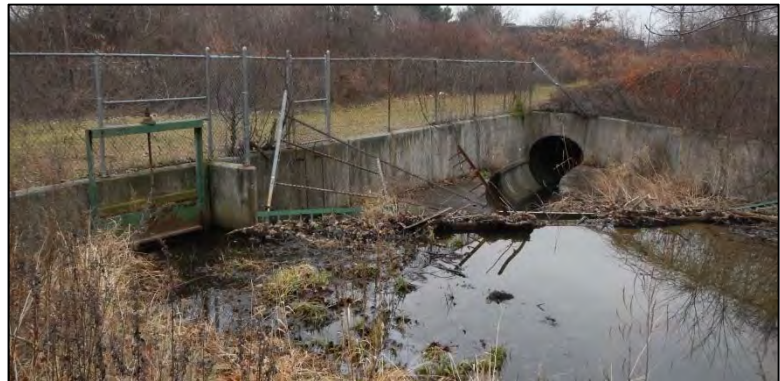
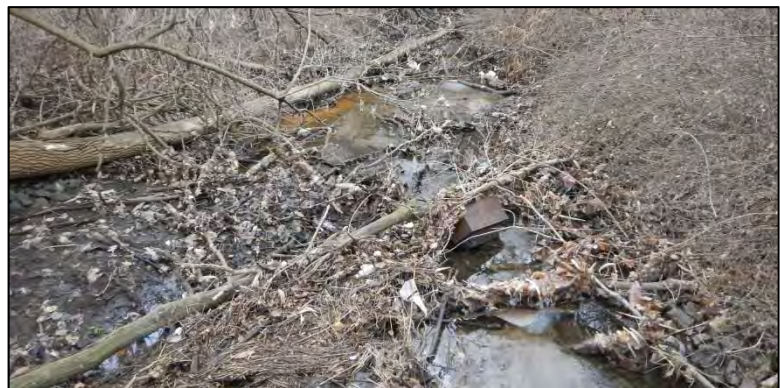
The downstream end of Reach #7 is a diversion structure that is located upstream of Applegate Lane. The structure was built by the Town of East Hartford in 1979. The purpose of this diversion was to alleviate flooding in Willow Brook by diverting flow to the Hockanum River. A sluice gate was installed at the culvert to allow the manipulation of flows in Willow Brook. However, the sluice has been closed for decades.

*Reach #7 Hockanum River Diversion Structure (upper photo)  
and upstream channel (lower photo)*

Upstream of the Hockanum River Diversion structure is a flat stretch of channel with a good vegetative buffer. The banks are low, with a high silt content. This channel reach is subject to accumulation of leaves and woody debris, as well as some trash along the channel. The average channel slope is 0.4%. Manmade detention areas are located on both banks of this reach, both of which appear to have been constructed in support of the adjacent commercial properties and their associated large impervious parking areas.

The Hockanum River diversion structure is located upstream of Applegate Lane. The structure was built by the Town of East Hartford in the late 1970s for the purpose of reducing flooding along Willow Brook. Water flows over a concrete weir and then into 84-inch diameter reinforced concrete pipe (RCP) that conveys water north approximately 2,100 linear feet beneath Interstate 84 to its terminus north of Olde Roberts Street. An open channel then conveys the discharge to the Hockanum River. The diversion is registered with the Connecticut Department of Energy and Environmental Protection (CTDEEP, Registration No. 4000-54-STO-RI).

A sluice gate on the culvert on Willow Brook adjacent to the diversion structure allows the manipulation of flows in Willow Brook. When open, water is allowed to flow downstream in Willow Brook. When fully closed, the entire flow of the brook is diverted via the diversion structure beneath Interstate 84 and into the Hockanum River. Even with the sluice in the open position, a large percentage of floodwaters are diverted to the Hockanum River.

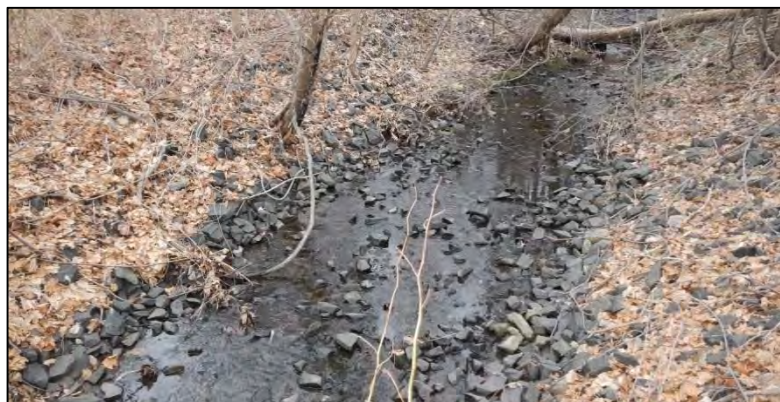
The upstream-most reach of Willow Brook has an average channel slope of 0.7%. This segment is slightly steeper than most other reaches, and does not exhibit the same debris accumulation. Directly upstream of the Charter Oak Mall is in a large flat wetland system that provides detention.

*Reach #8 Charter Oak Mall to Silver Lane Outfalls*

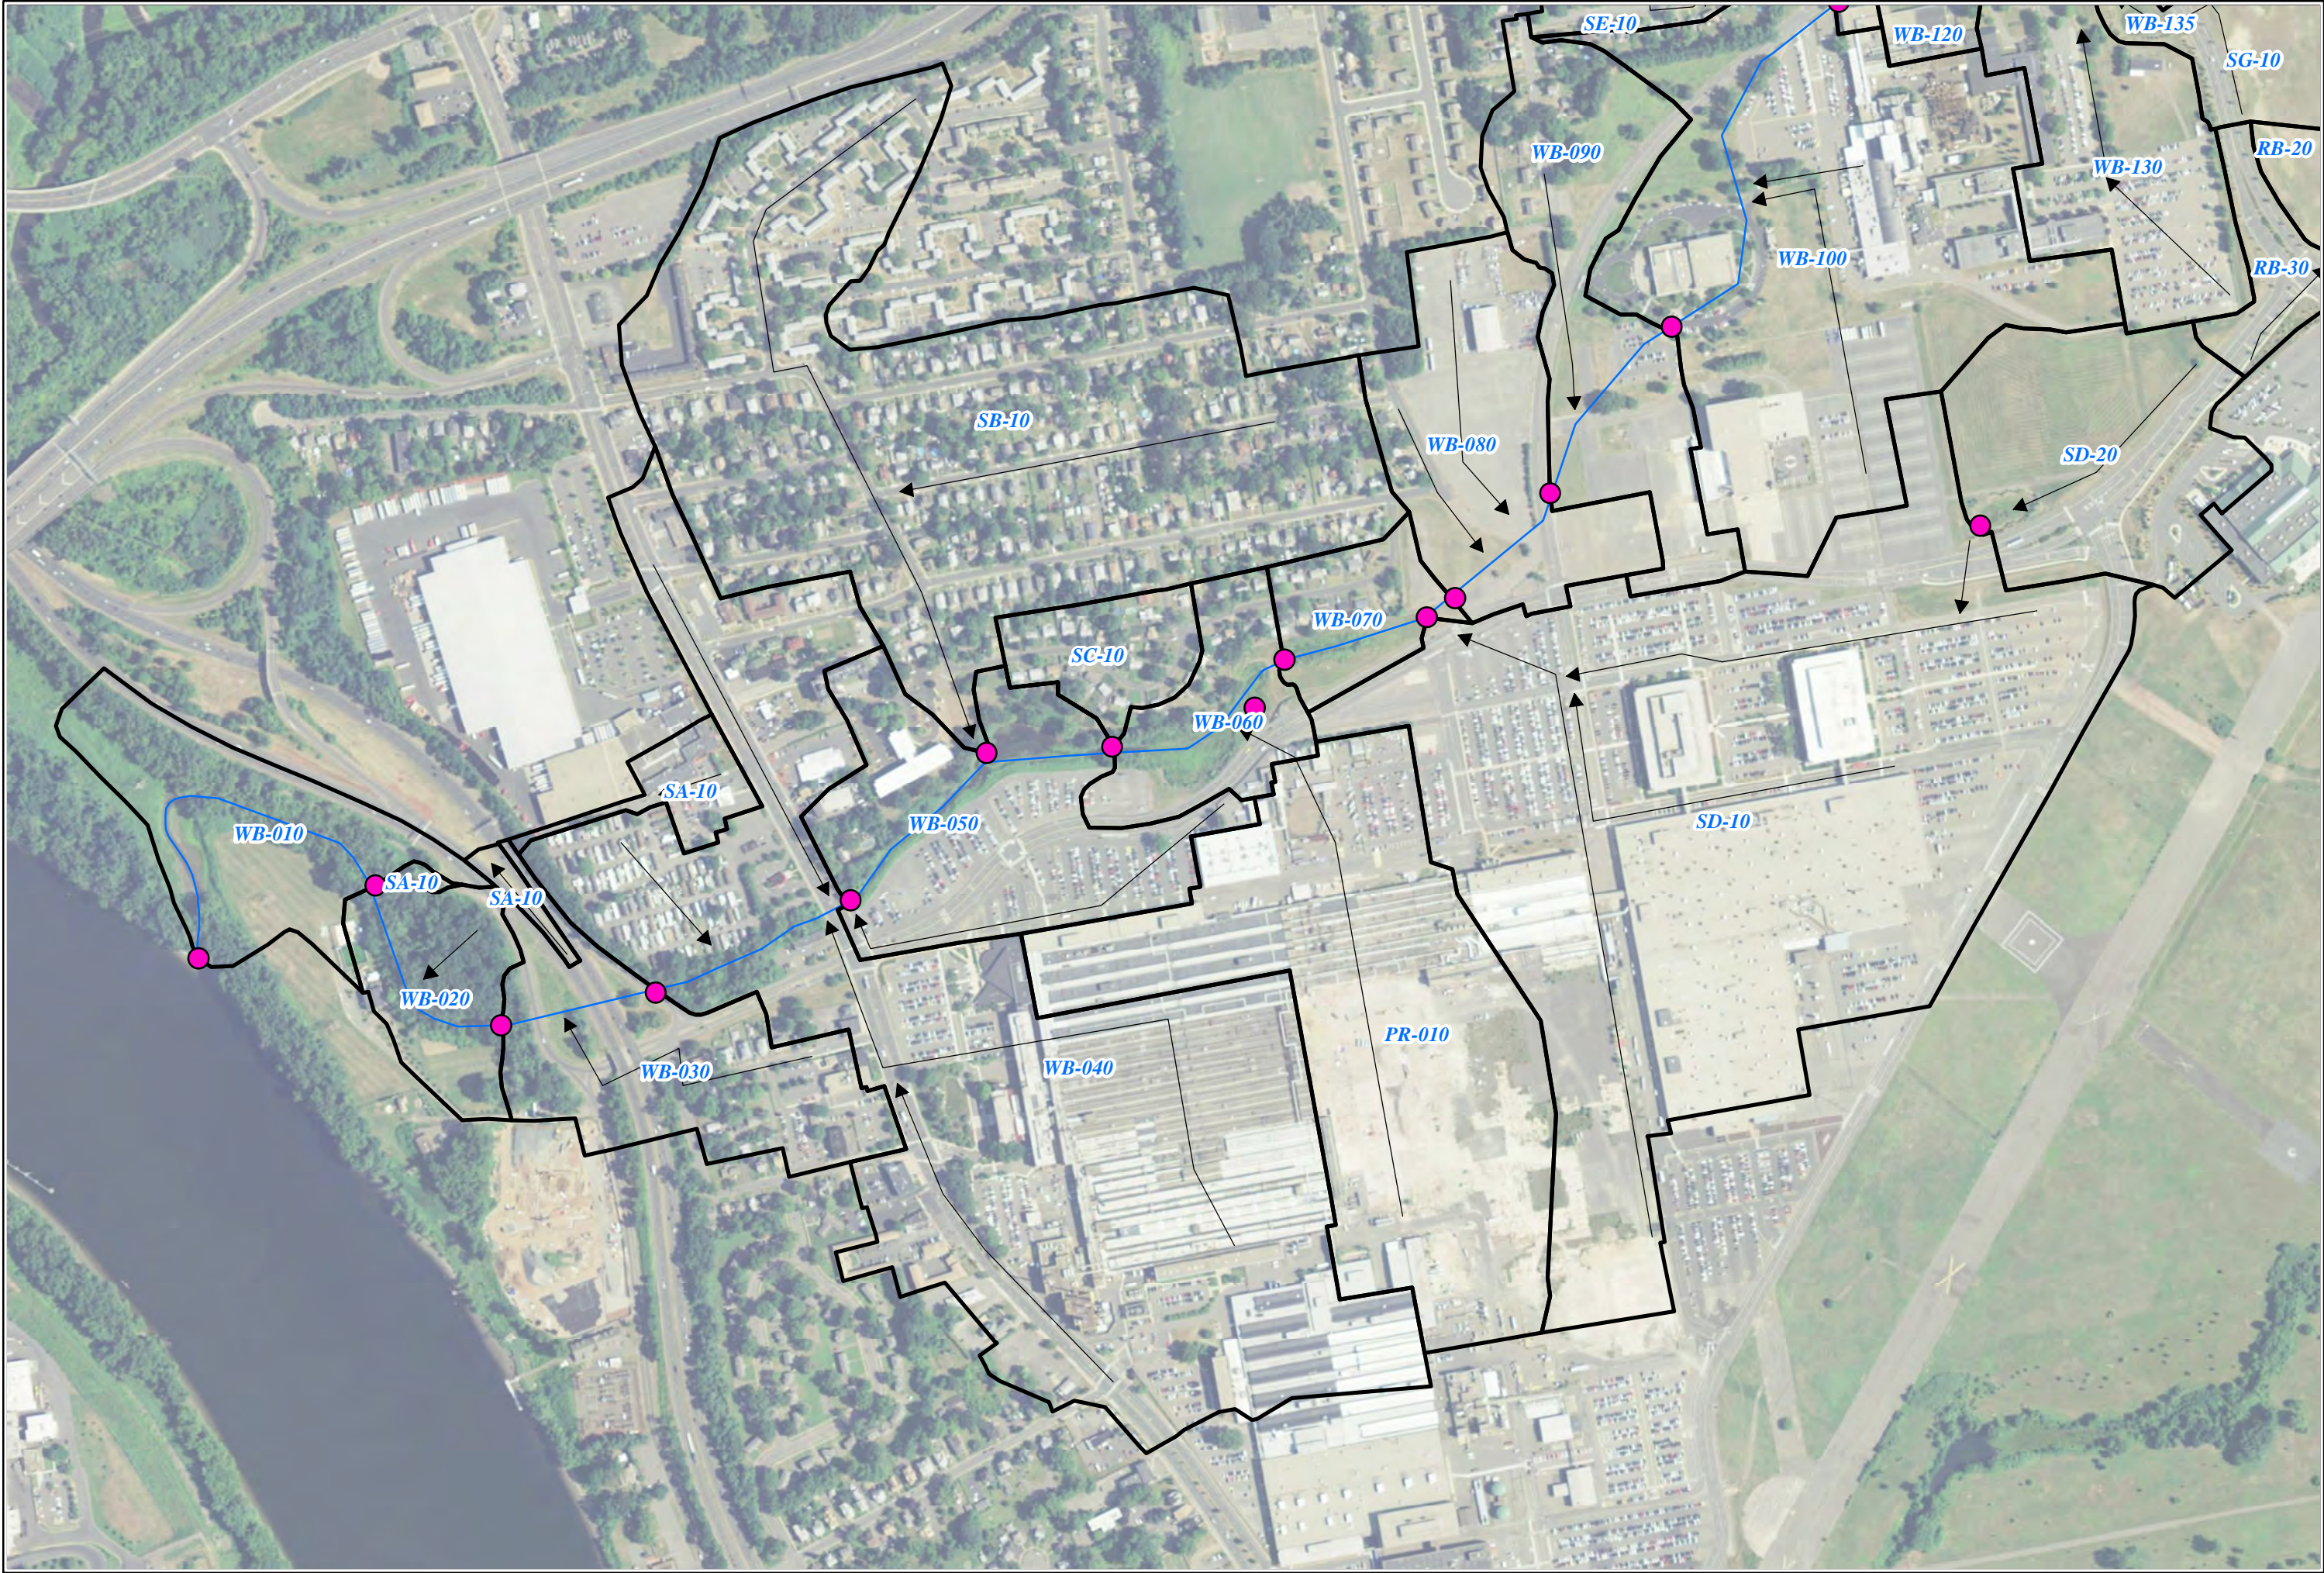
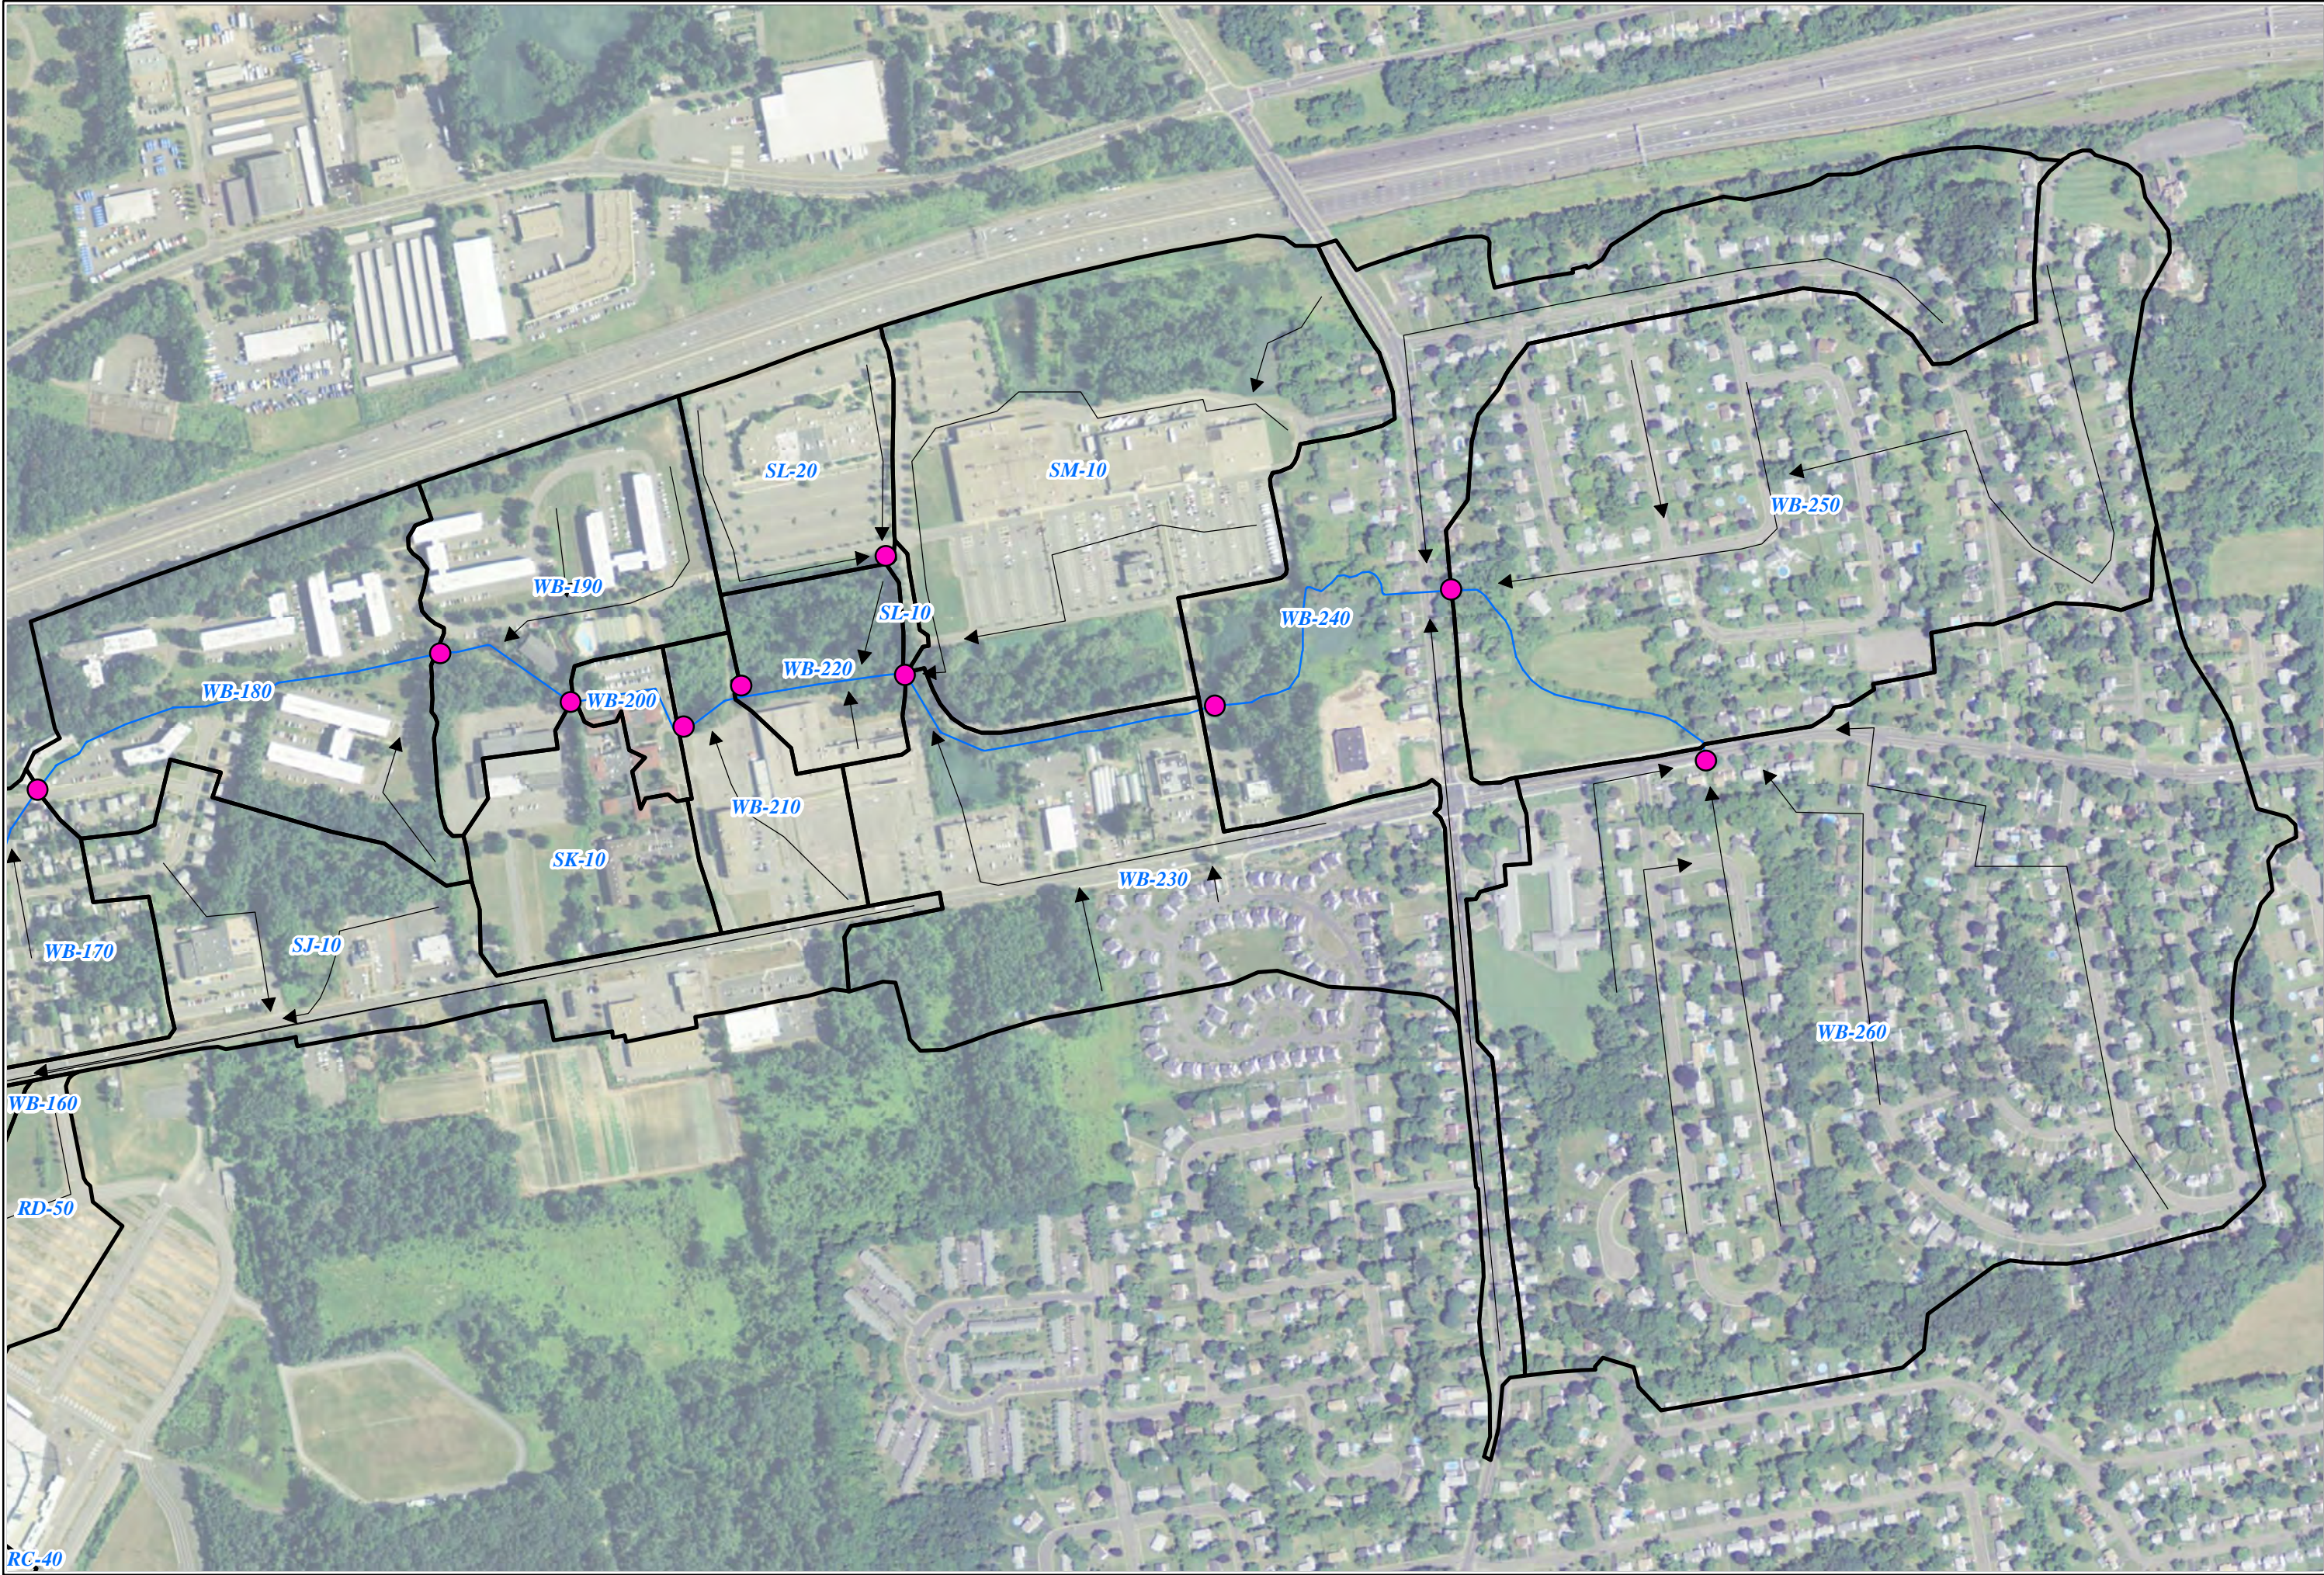
<b>Map By:</b> CMP <b>MM#:</b> 2854-37 <b>MXD:</b> V:\2854-37\GIS\Maps\Lower Sub-Watershed Turned <b>1st Version:</b> 2/10/2015 <b>Revision:</b> 8/3/2015 <b>Scale:</b> 1 in = 500 ft	<b>Sub-Watershed Flow Direction</b> <b>Willow Brook Flood Mitigation Study</b> <b>East Hartford, Connecticut</b>	<b>SOURCE(S):</b> Pratt and Whitney Town of East Hartford CT DEEP 2012 Aerial Imagery

Willow Brook does not appear to have any natural tributaries, although several storm drainage ditches are directed to the brook. Numerous stormwater outfalls also direct flow into the brook. In order to properly account for the numerous flow inputs into the main stem of Willow Brook, the watershed was divided into 57 sub-watersheds for analysis. Table 3-9 provides a general geographic description of the outlet point or point of analysis of each sub-watershed. Figures 3-1, 3-2, and 3-3 present the overall watershed boundary and the delineated sub-watershed boundaries. Nomenclature for the sub-watersheds is provided as follows:

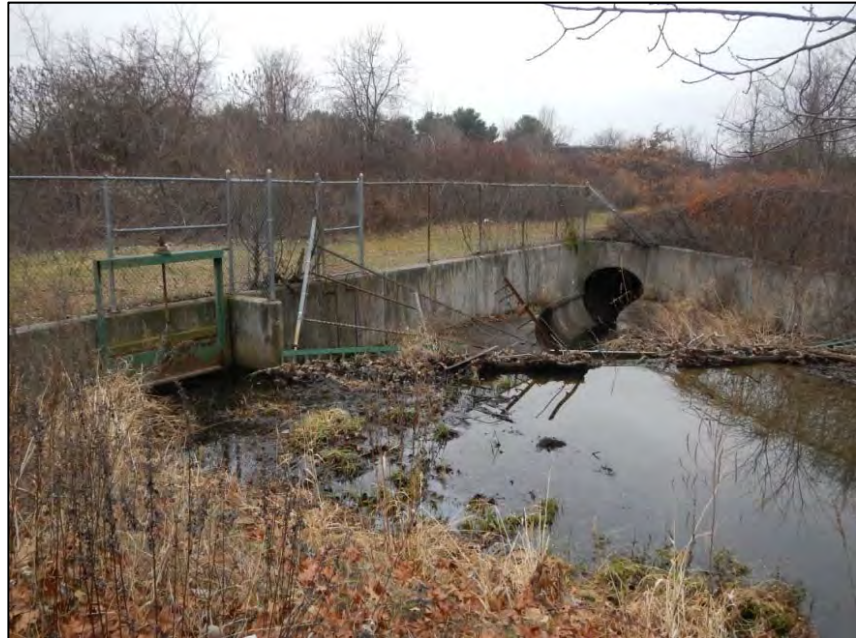
**Photo: Hockanum River Diversion Structure, Looking Downstream**

FEMA developed hydraulic modeling of the Hockanum River diversion structure based upon a rating curve, such that no flow is diverted into the Hockanum during the 10-year storm and only 11.2% of the upstream flow is diverted under the 100-year (1% ACR) storm. The assumptions of the FEMA model were made prior to the construction of the diversion channel, which was completed after the publication of the FEMA FIS.

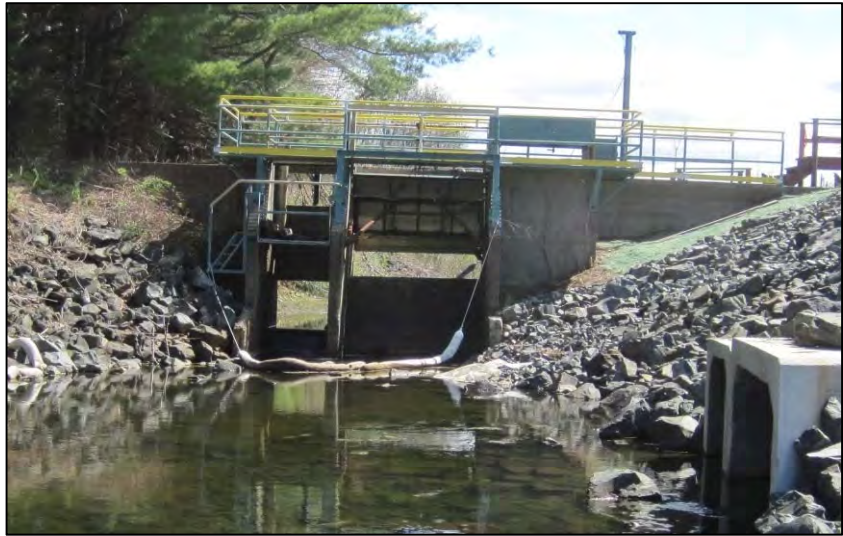
The Pratt & Whitney Dam is a concrete structure that was originally constructed to impound water and create a small pond/reservoir. This impoundment reportedly provided process water for use in the factory for various cooling, cleaning, and industrial processes. The dam was designed to provide easy manipulation of the upstream water surface elevations through multiple openings, weir boards, and a tainter gate. The dam is approximately 12 feet tall and 63 feet wide at its crest. It is constructed of concrete, with multiple openings and gates used to control flow. A three-foot high by eight-foot wide tainter gate provides the majority of flow control through the structure, with two other rectangular openings controlled by flashboards. The operators for these gates are located on the top of the dam, where railing and walkways have been constructed for pedestrian and maintenance access.

***Photo: Pratt & Whitney Dam, Looking Upstream***

Historically, Pratt & Whitney withdrew process and/or cooling water from the lower pond on Willow Brook, though they reportedly have not done so in many years. The water diversion from this impoundment is registered with the Connecticut Department of Energy and Environmental Protection (CTDEEP, Registration No. 4000-017-IND-1M), authorizing the consumption of up to 21 million gallons per day (or approximately 32.5 cubic feet per second sustained over 24 hours) from the pond.

When diversion registrations were first filed in the early 1980s, it was common practice to report a peak instantaneous withdrawal rate based on pump or pipe capacity, regardless of whether the stream ecology could sustain the withdrawal. Relative to Pratt & Whitney's total daily registered diversion of 21 mgd, the capacity of the lower pond is only 3.5 million gallons (based on 2015 survey by MMI), or about four hours of pumping at the diversion flow rate.

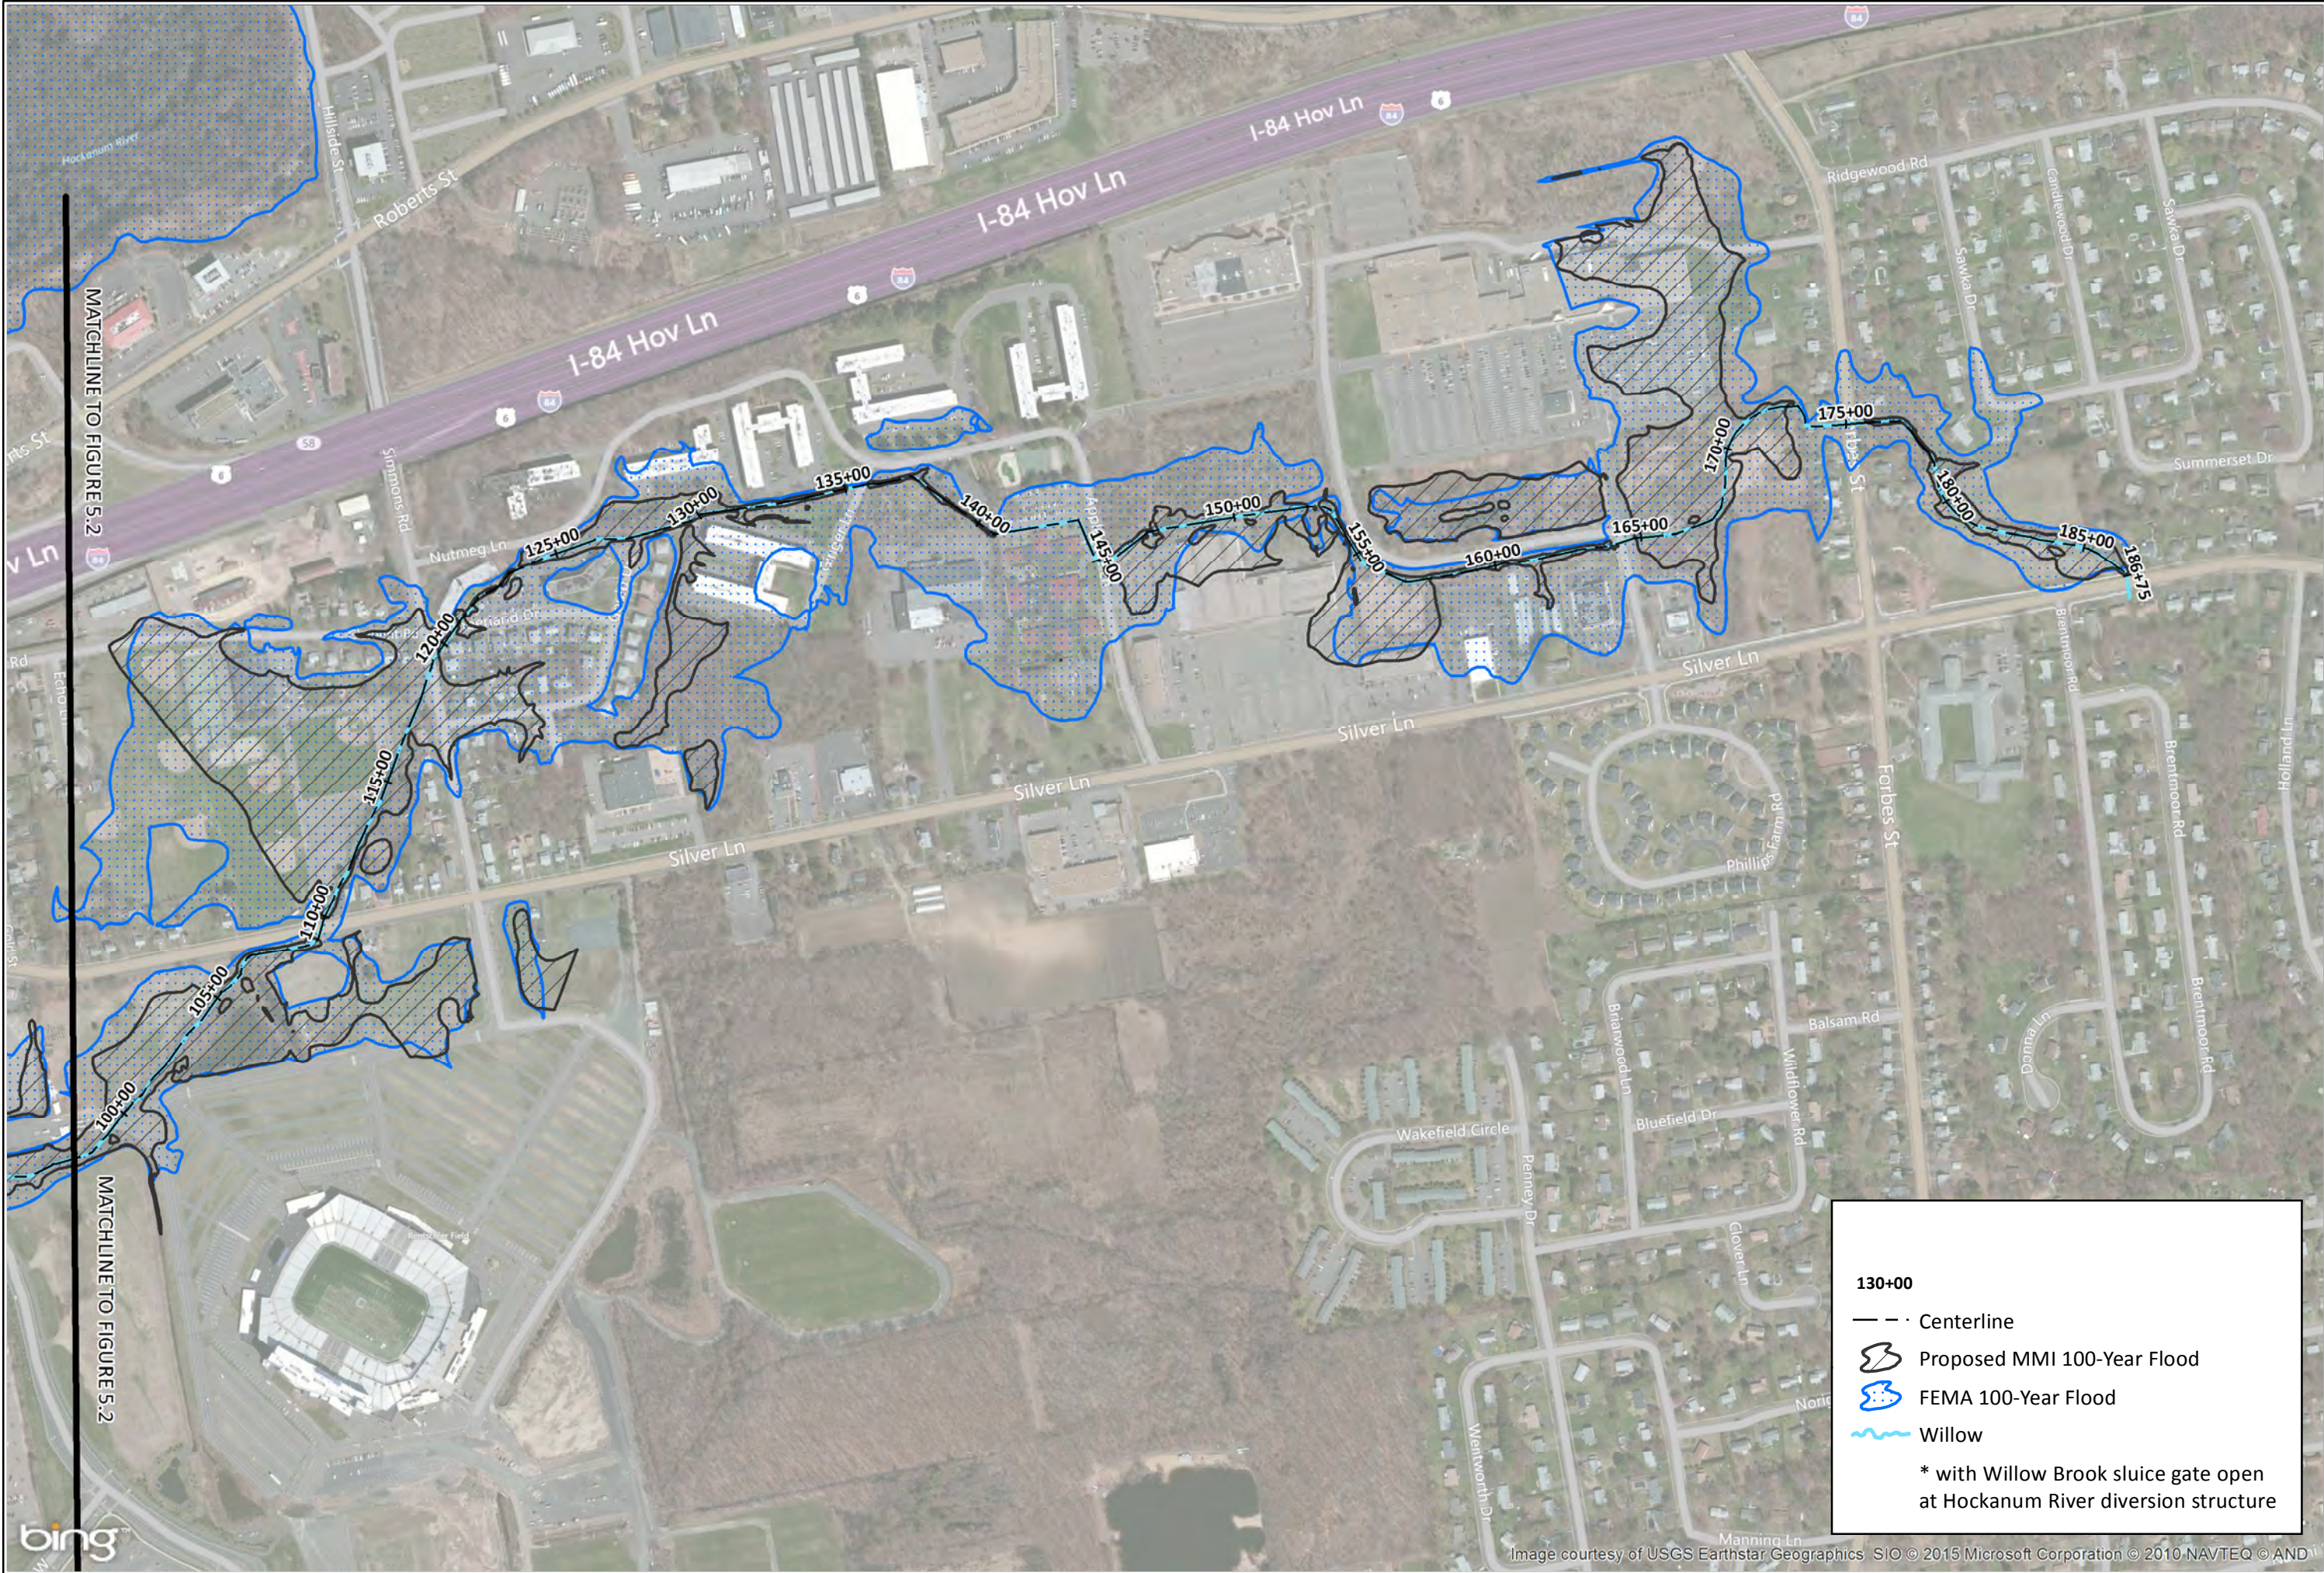
Figure 5-1

Map By: JCS MM#1: 2854-37 MXD: Y:\2854-37\GIS\Maps\2bL_ExCond_1_11x17.mxd 1st Version: 7/22/2015 Revision: 11/17/2015 Scale: 1 in = 500 ft		<b>WILLOW BROOK EXISTING CONDITIONS</b> <b>WILLOW BROOK FLOOD MITIGATION STUDY</b> <b>EAST HARTFORD, CONNECTICUT</b>		SOURCE(S): FEMA, BASE LAYER: IMAGE COURTESY OF USGS EARTHSTAR GEOGRAPHICS SIO (C) 2015 MICROSOFT CORPORATION (C) 2015	 99 Realty Drive Cheshire, Connecticut 06410 (203) 271-1773 Fax (203) 272-9733 www.miloneandmacbroom.com

The above changes are reflected in the current hydraulic modeling and were used to generate a revised existing conditions floodplain map. This mapping reflects an updated and more accurate portrayal of the flooding characteristics for the 100-year (1% ACR) flood in Willow Brook. Figures 5-1 and 5-2, present the changes as a result of this analysis.

As depicted in these figures, many areas located just downstream of the Hockanum River diversion structure (just upstream of Applegate Lane) are removed from the floodplain under MMI existing conditions hydrology and hydraulic analysis. This is due in large part to the structure diverting much of the flood flow from Willow Brook, northerly to the Hockanum River watershed.

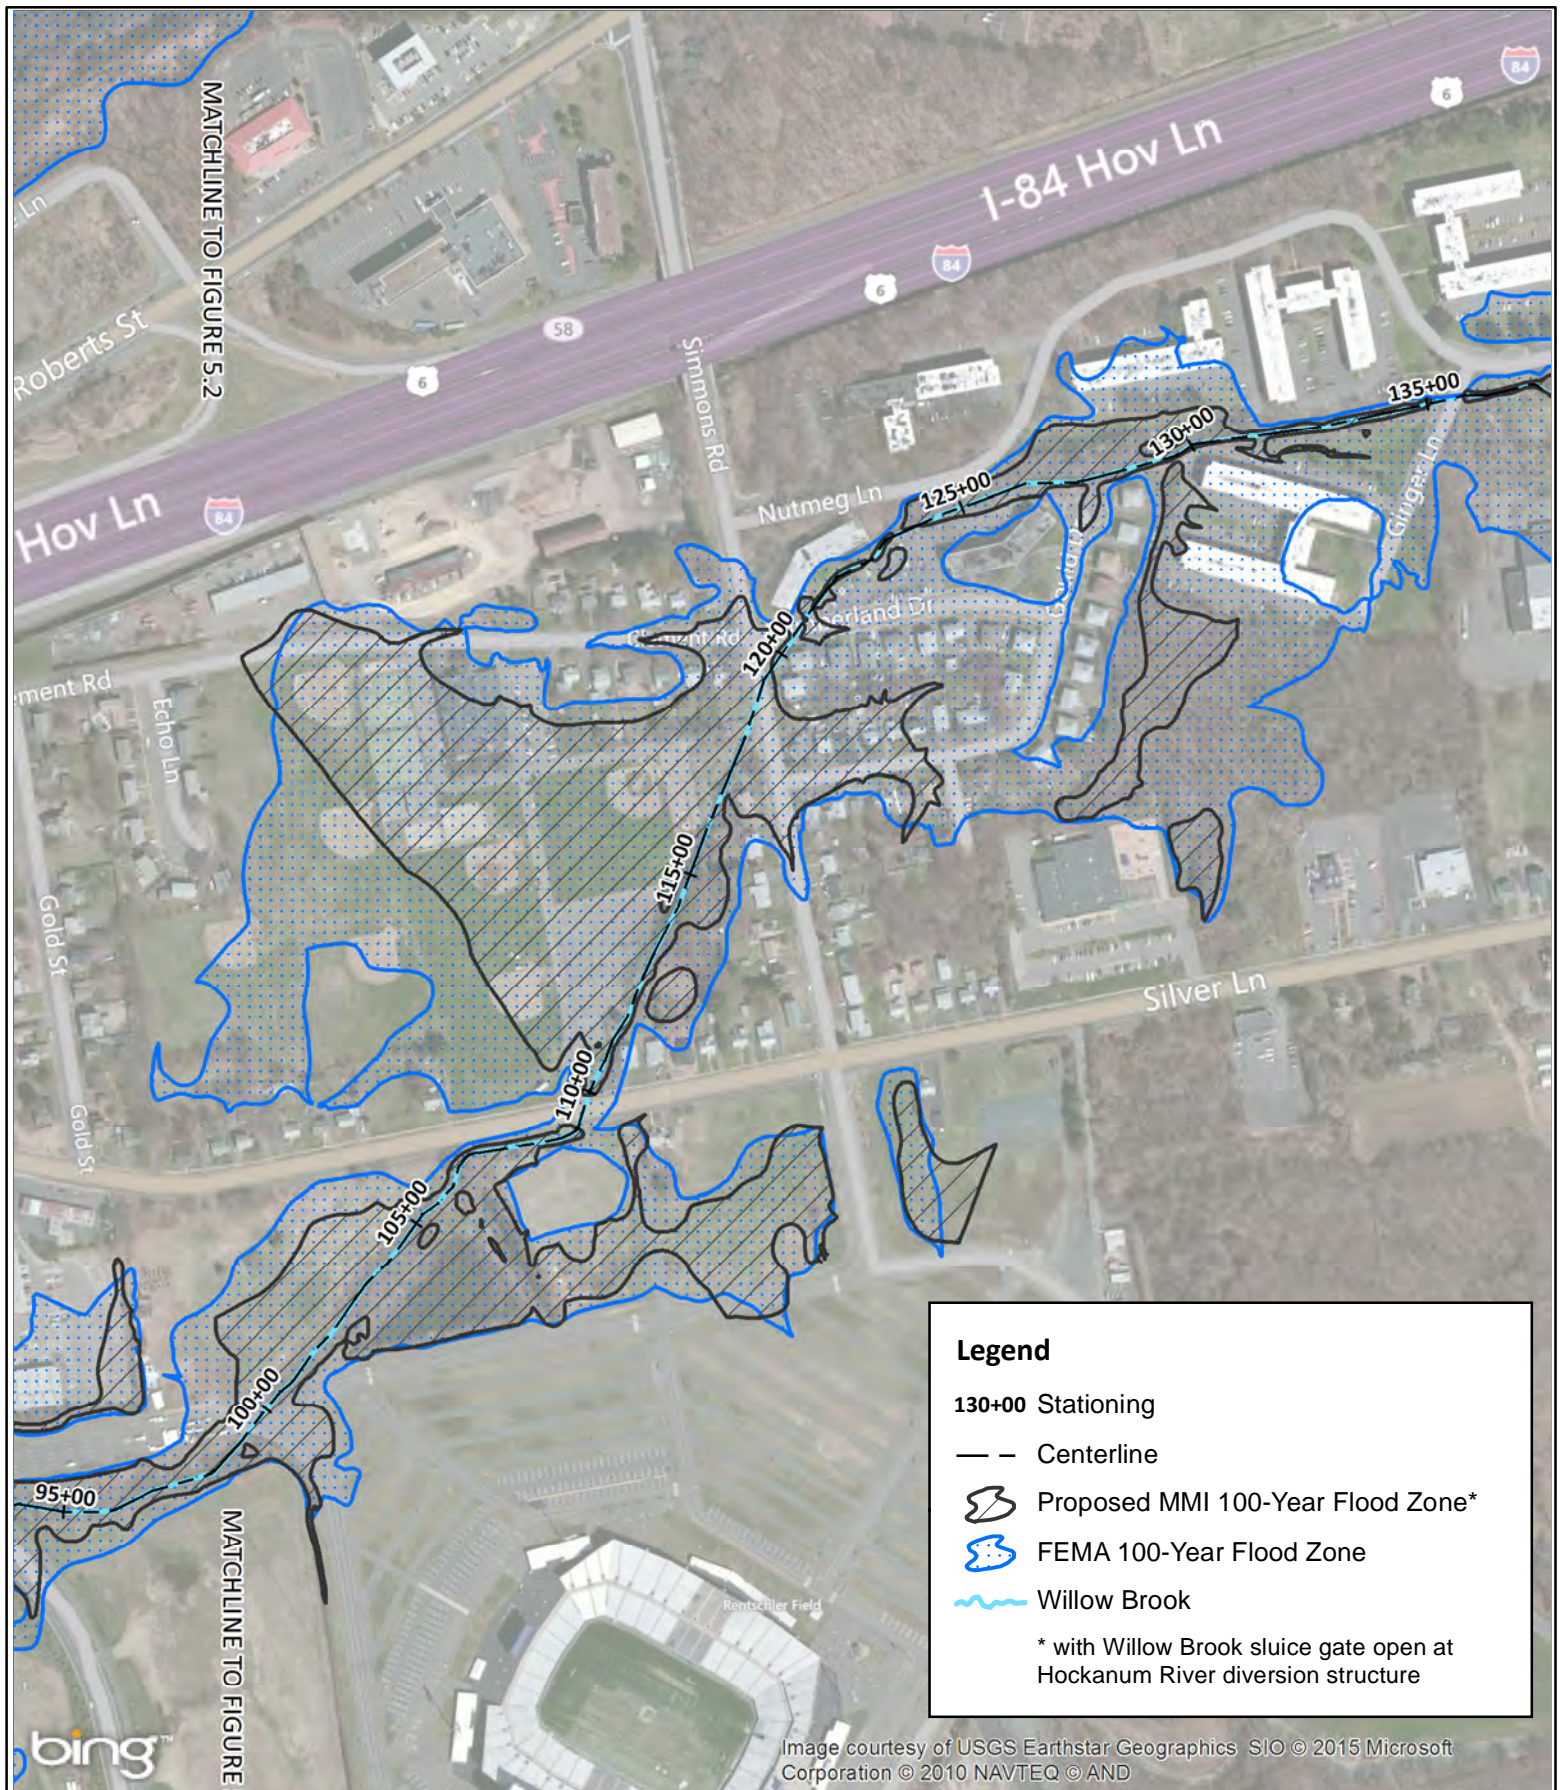
**Area 2: Proposed LOMR Updated Floodplain Mapping  
for Simmons Road and Cumberland Drive Area**

The updated hydraulic analysis and mapping of existing conditions described in Section 5.2 would remove approximately 36 residential homes and 4 multi-story apartment buildings (Woodcliff Estates) in this area from the delineated floodplain, as well as generally reducing the extents of the floodplain in the area. Figure 5-4 presents the modified floodplain according to the updated analysis. Figure 5-5 is a location plan of the Simmons Road and Cumberland Drive residential area.
