# Willow Brook Flood Mitigation Study

East Hartford, Connecticut

August 2016

MMI #2854-37-5

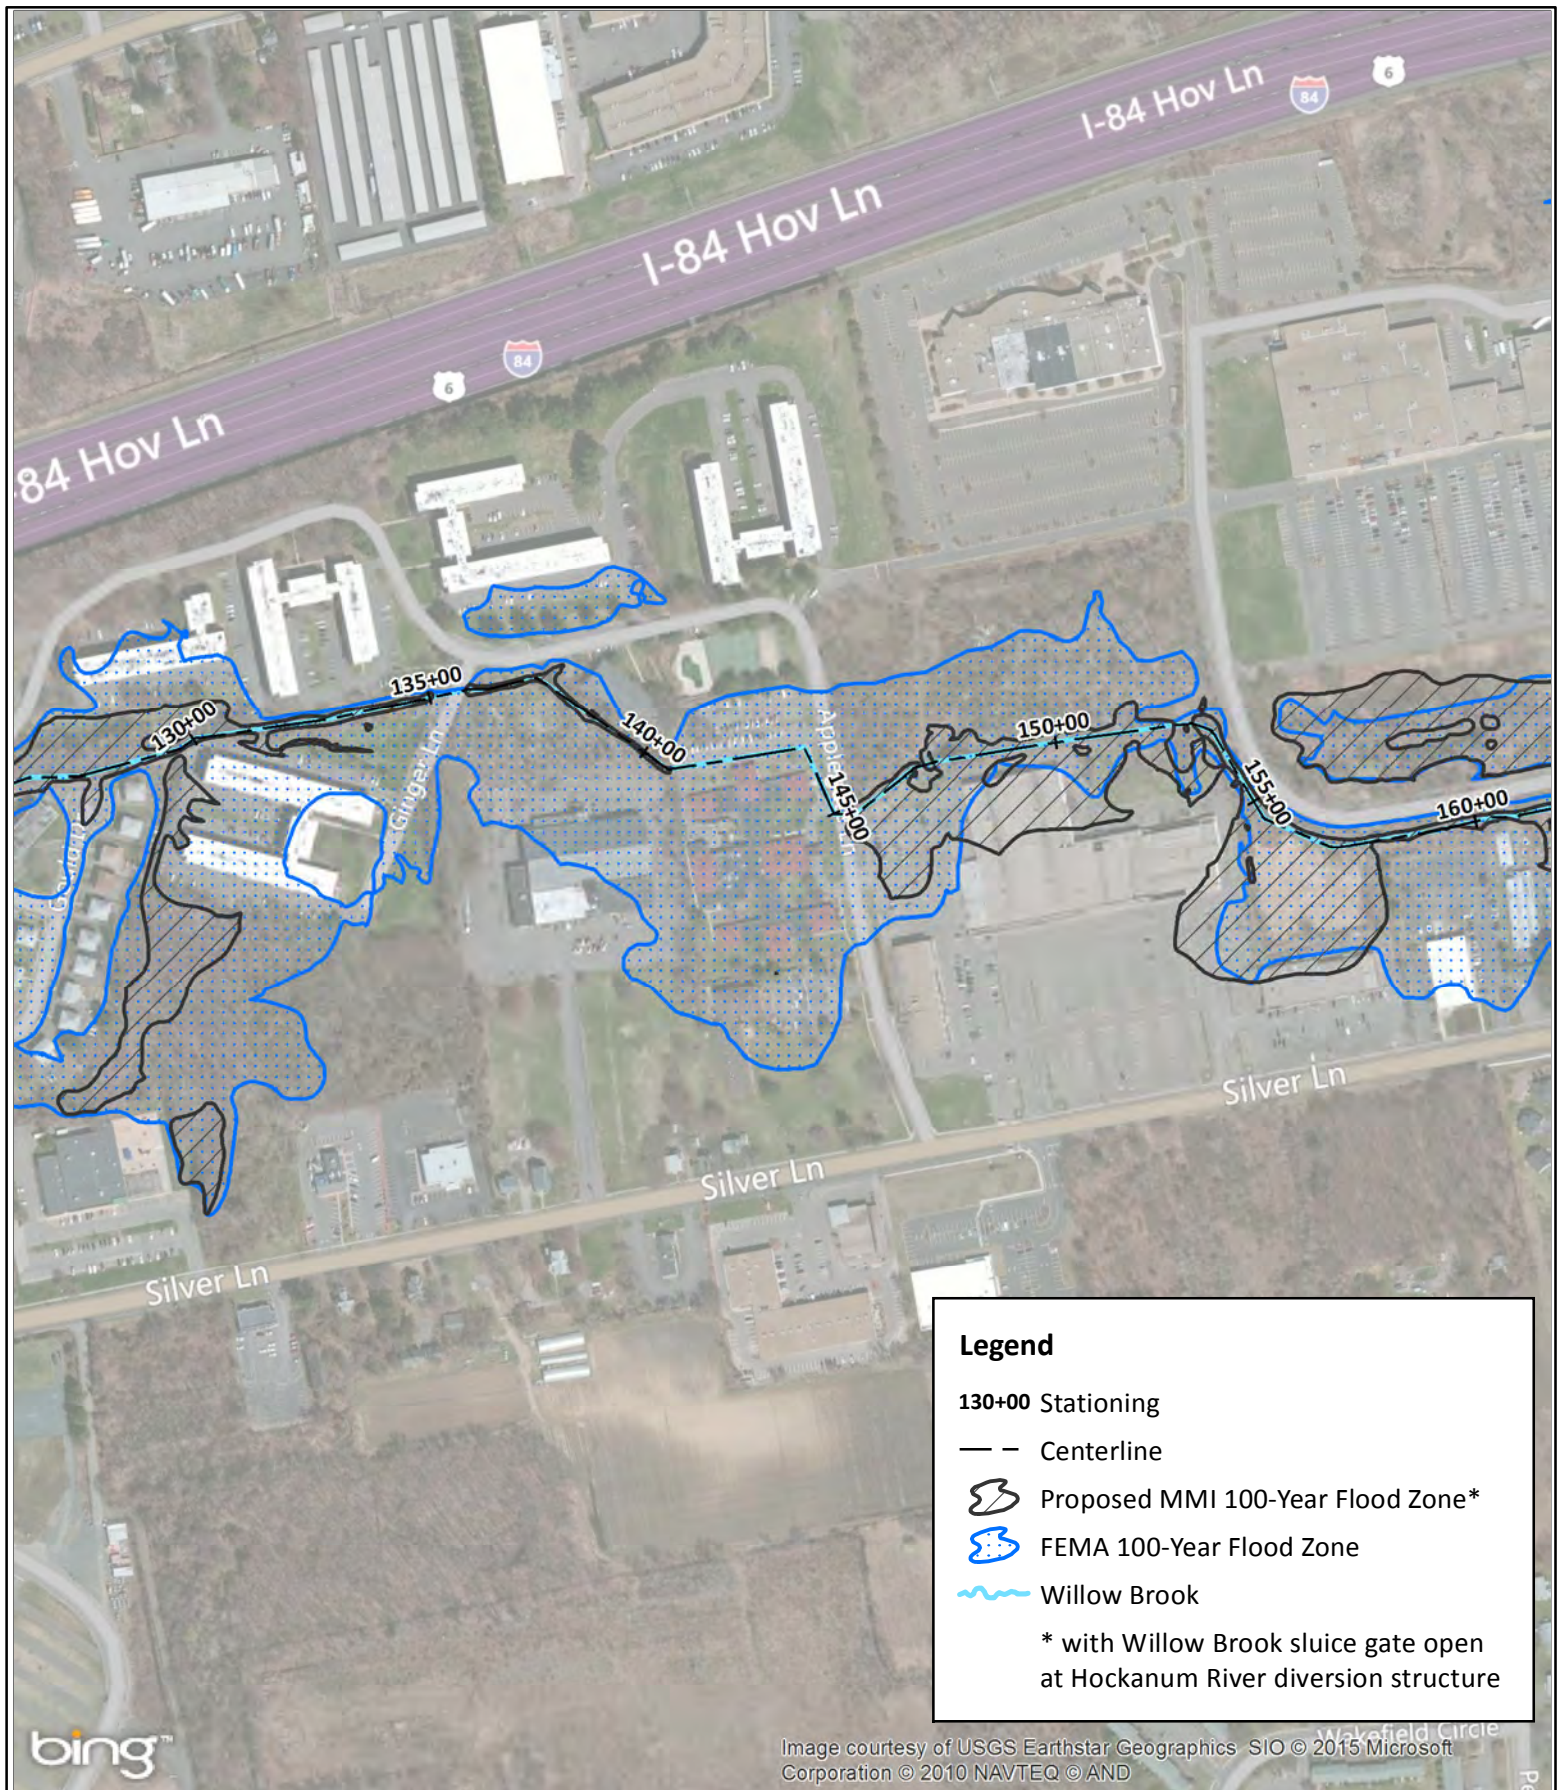
<p><b>SOURCE(S):</b> FEMA, USGS, Microsoft</p>	<p><b>Area 3: Proposed LOMR Updated Floodplain Mapping for Applegate Lane Area</b></p>	<p><b>LOCATION:</b> East Hartford, Connecticut</p>
<p><b>Figure 5-10</b></p>	<div data-bbox="380 1919 444 2053"> </div> <div data-bbox="444 1919 980 2053"> <p><b>Willow Brook Flood Mitigation Study</b></p> <p>MXD: Y:\2854-37\GIS\Maps\Applegate Lane 8x11.mxd</p> </div> <div data-bbox="980 1919 1143 2053"> <p>Map By: JCS MMI#: 2854-37 Original: 9/2/2015 Revision: 11/18/2015 Scale: 1 inch = 400 feet</p> </div>	<div data-bbox="1240 1919 1588 2053"> <p><b>MILONE &amp; MACBROOM</b> 99 Realty Drive Cheshire, CT 06410 (203) 271-1773 Fax: (203) 272-9733 www.miloneandmacbroom.com</p> </div>

An assisted living/medical facility, as well as a bowling alley, and a building associated with a nearby apartment complex have been mapped in the FEMA floodplain in the Applegate Lane area. Figure 5-10 depicts the FEMA delineated floodplain in this area. Figure 5-11 is a detailed location plan. Through public outreach, informational meetings, and discussions with the Town, no records or reports of flooding in the area have been identified. Removing non-flood prone homes from the Special Flood Hazard Area (SFHA) would eliminate the need to carry flood insurance.

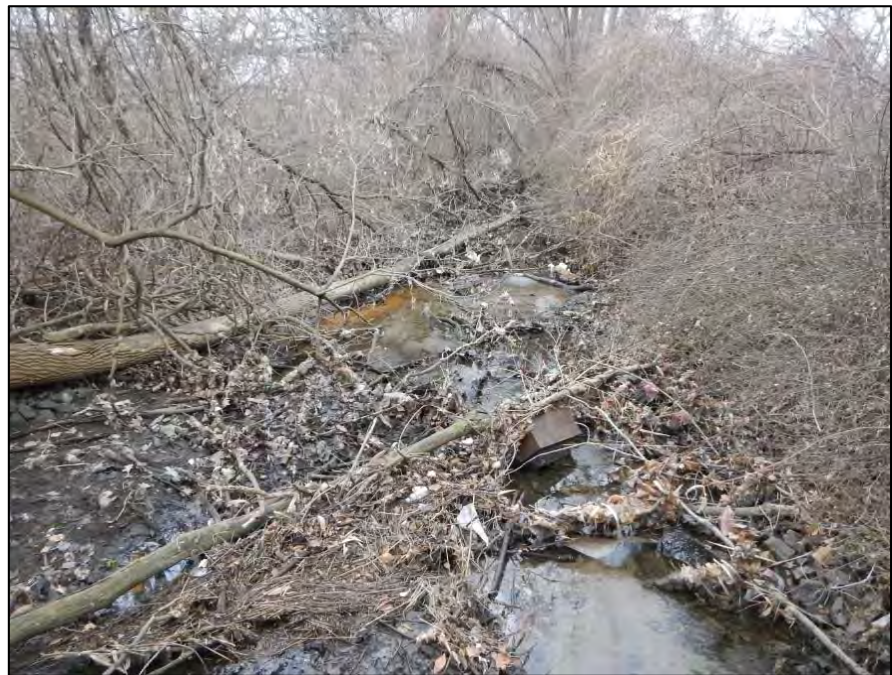
The Willow Brook channel located to the north of the Silver Lane Plaza is a relatively flat segment that has been subject to debris and sediment accumulation. This accumulation has had the effect of reducing the ability of this reach of channel to effectively convey flood flows, and exacerbates flooding in the area. Cleaning and widening of the channel for approximately 800 linear feet starting upstream of the Hockanum River diversion structure was assessed in the hydraulic modeling to explore the effects on flood elevations.

***Photo: Debris in Willow Brook behind Silver Lane Plaza***

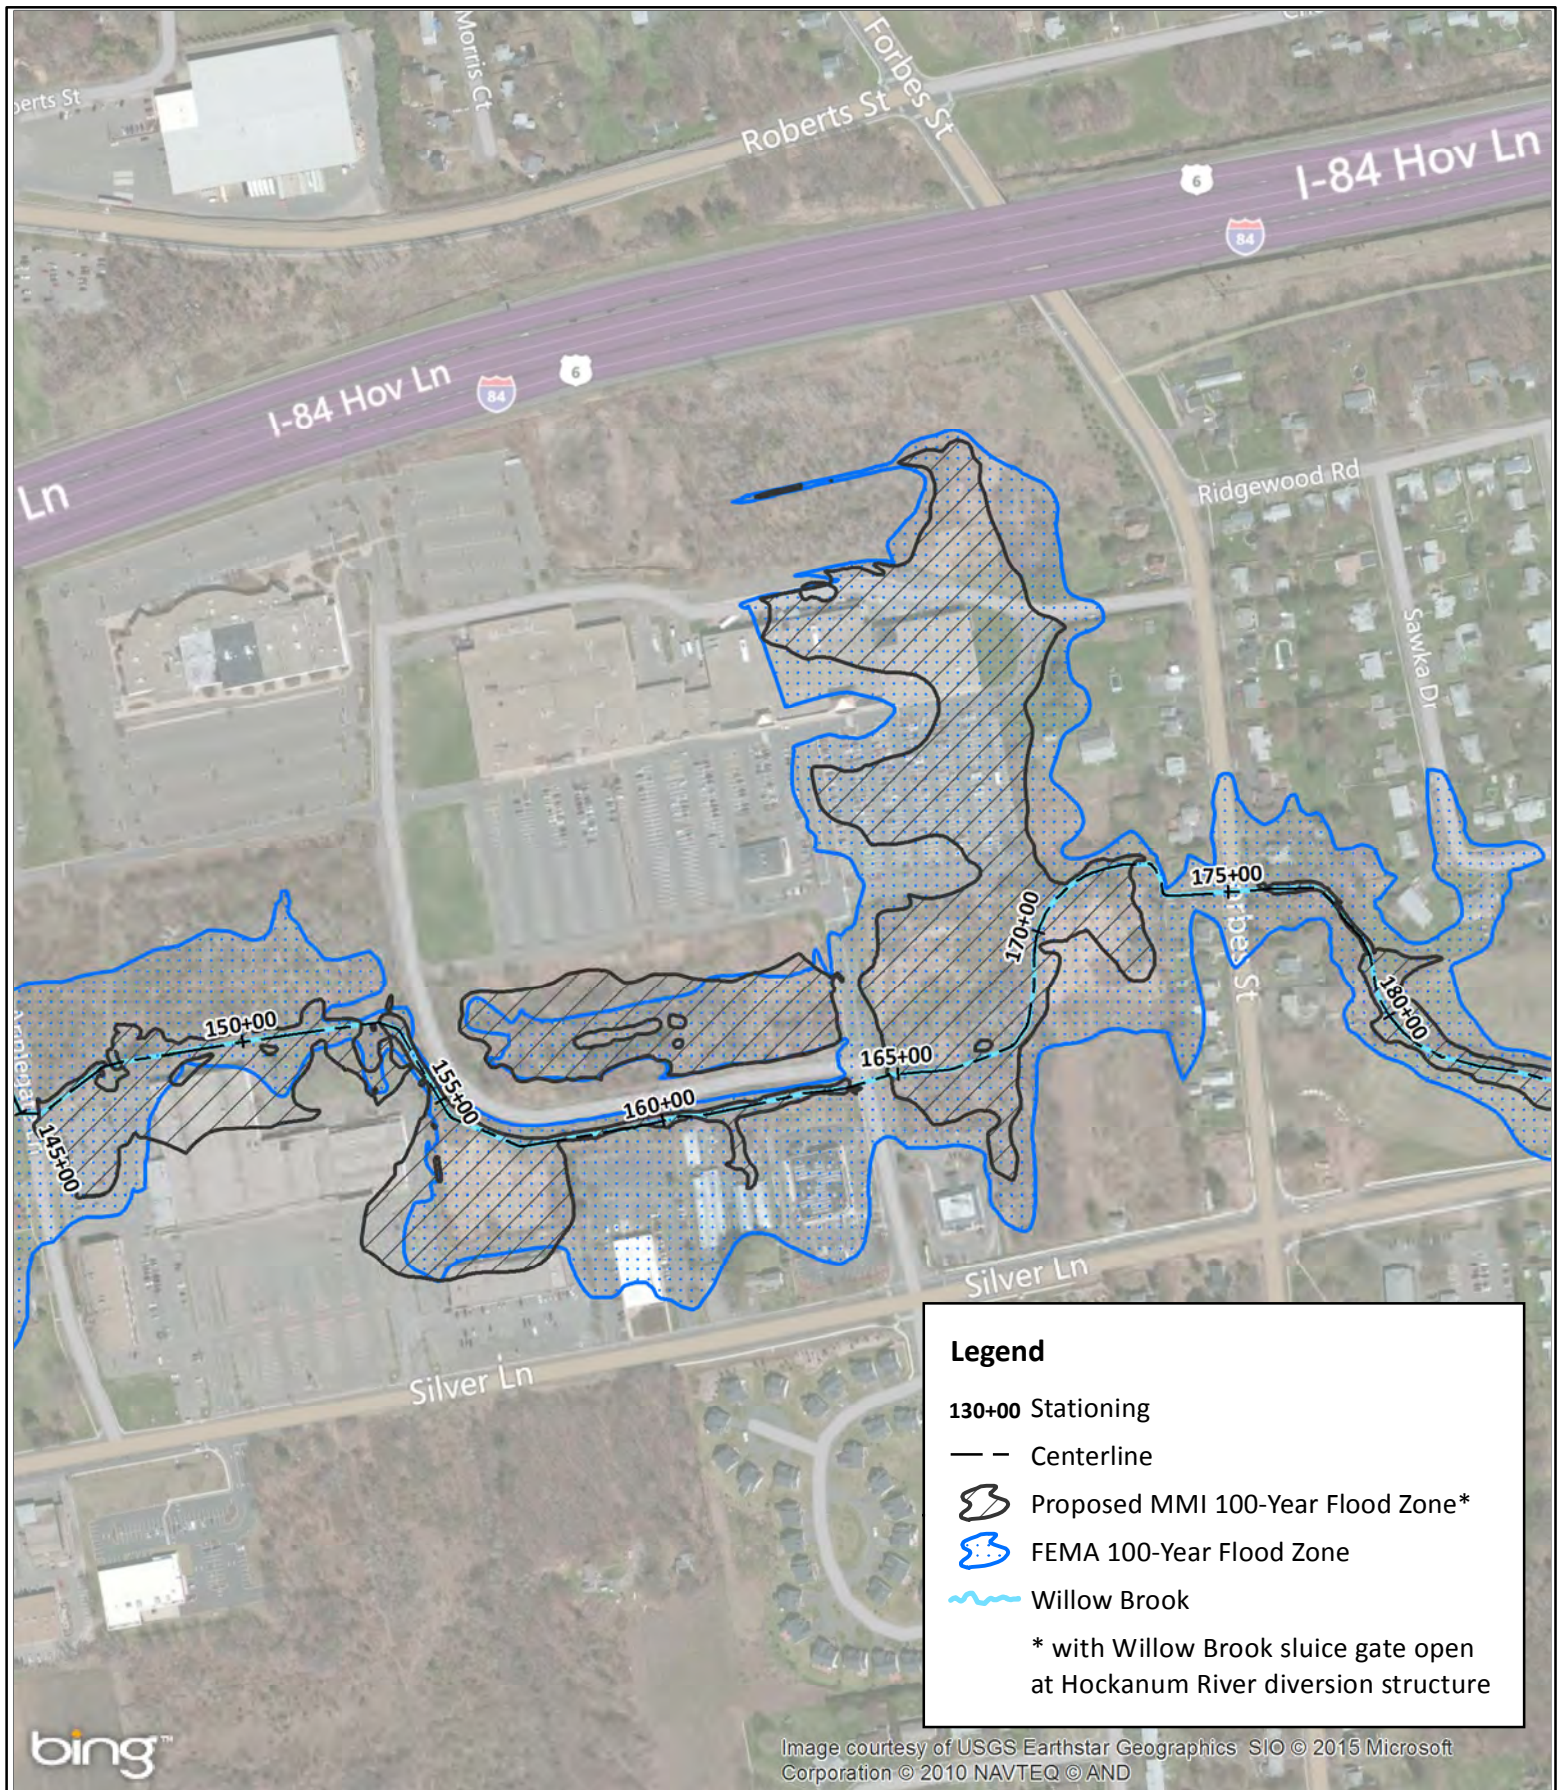
**Area 4: Proposed LOMR Updated Floodplain Mapping  
for Upstream of Applegate Lane**

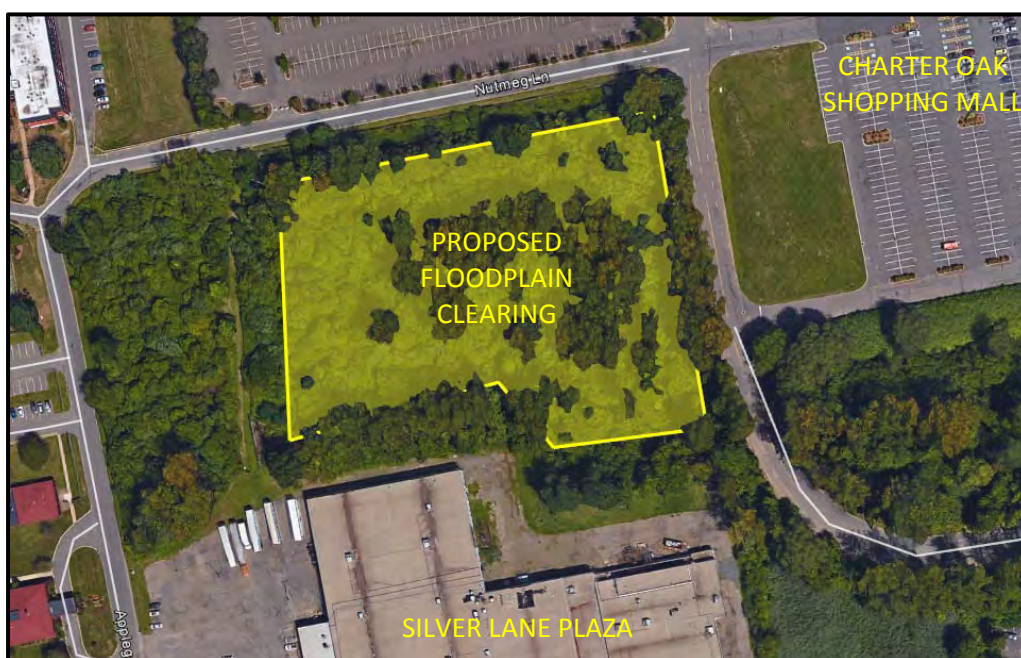
The lowering of an adjacent wooded floodplain to the north of the Silver Lane Plaza was explored as an alternative to raising the land. This would provide a greater area for floodwaters to spread out, potentially lowering flood elevations. Iterative trials were performed to determine by how much the floodplain would have to be lowered in order to remove the adjacent area from the 100-year (1% ACR) floodplain. A large swath of land would have to be clear-cut and a large volume of material would have to be removed from the site in order to achieve a significant flood benefit. The area of clearing is estimated as 500 linear feet by 350 feet wide of clearing trees and average cuts of 3 feet deep, as shown in the yellow hatched area in Figure 5-18. Figure 5-19 presents a cross sectional view. Figure 5-20 presents the model results.

**FIGURE 5-18**  
**Floodplain to be Cleared and Lowered - Aerial View of Extents**

In order to remove the existing building from the floodplain, it is estimated that an approximate volume of material to be removed from the site would be 20,000 cubic yards, or 1,400 triaxle dump truck loads. It is unlikely that such an endeavor would be financially feasible, given the immense cost that would be required.

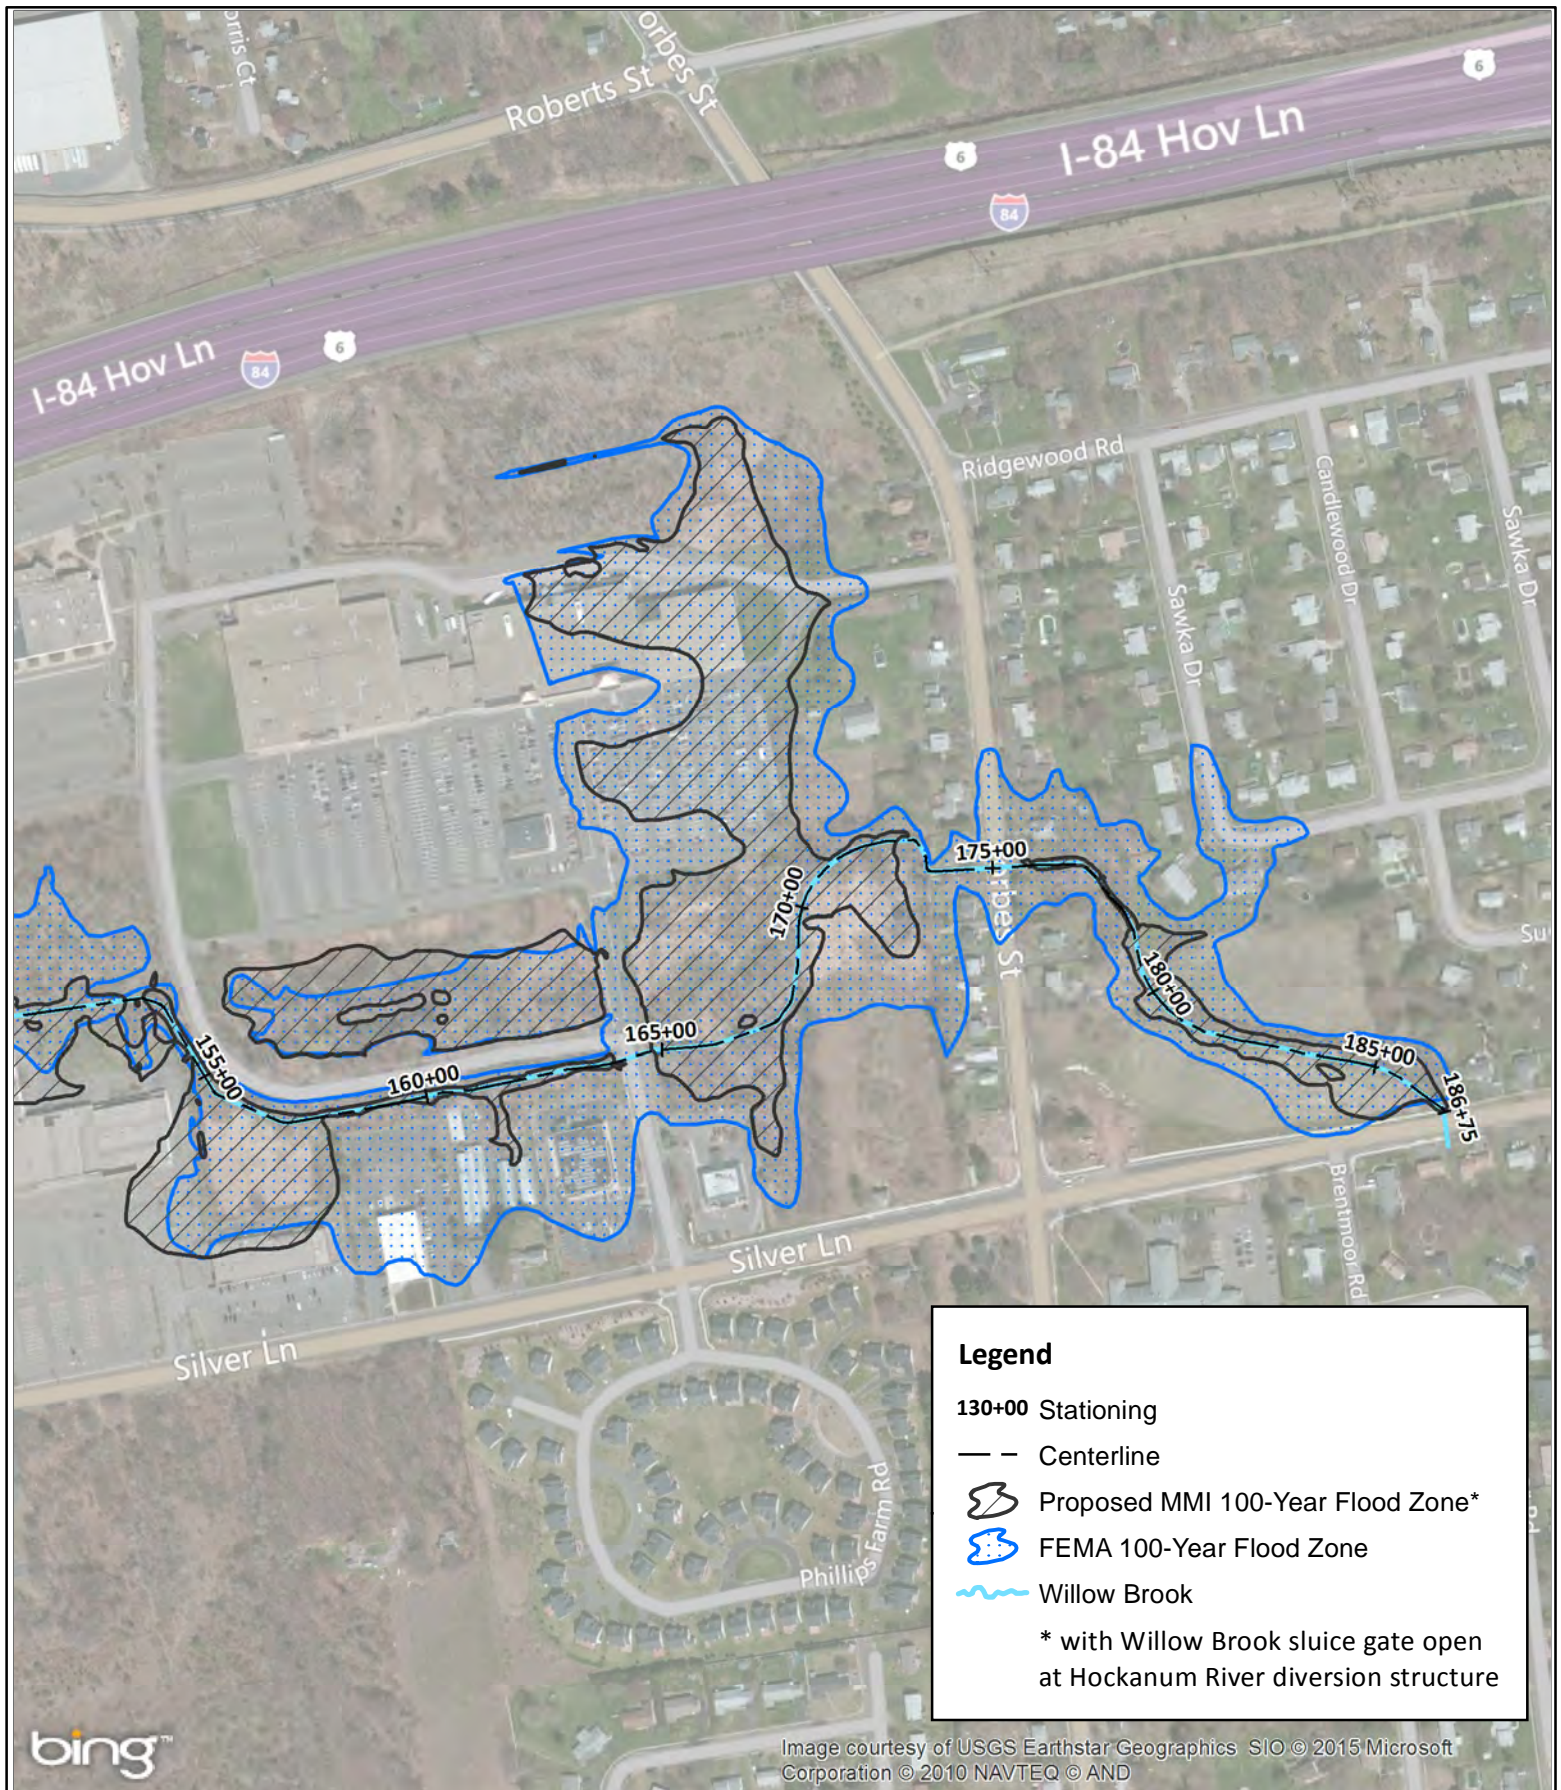
**Area 5: Proposed LOMR Updated Floodplain Mapping  
Downstream of Forbes Street**

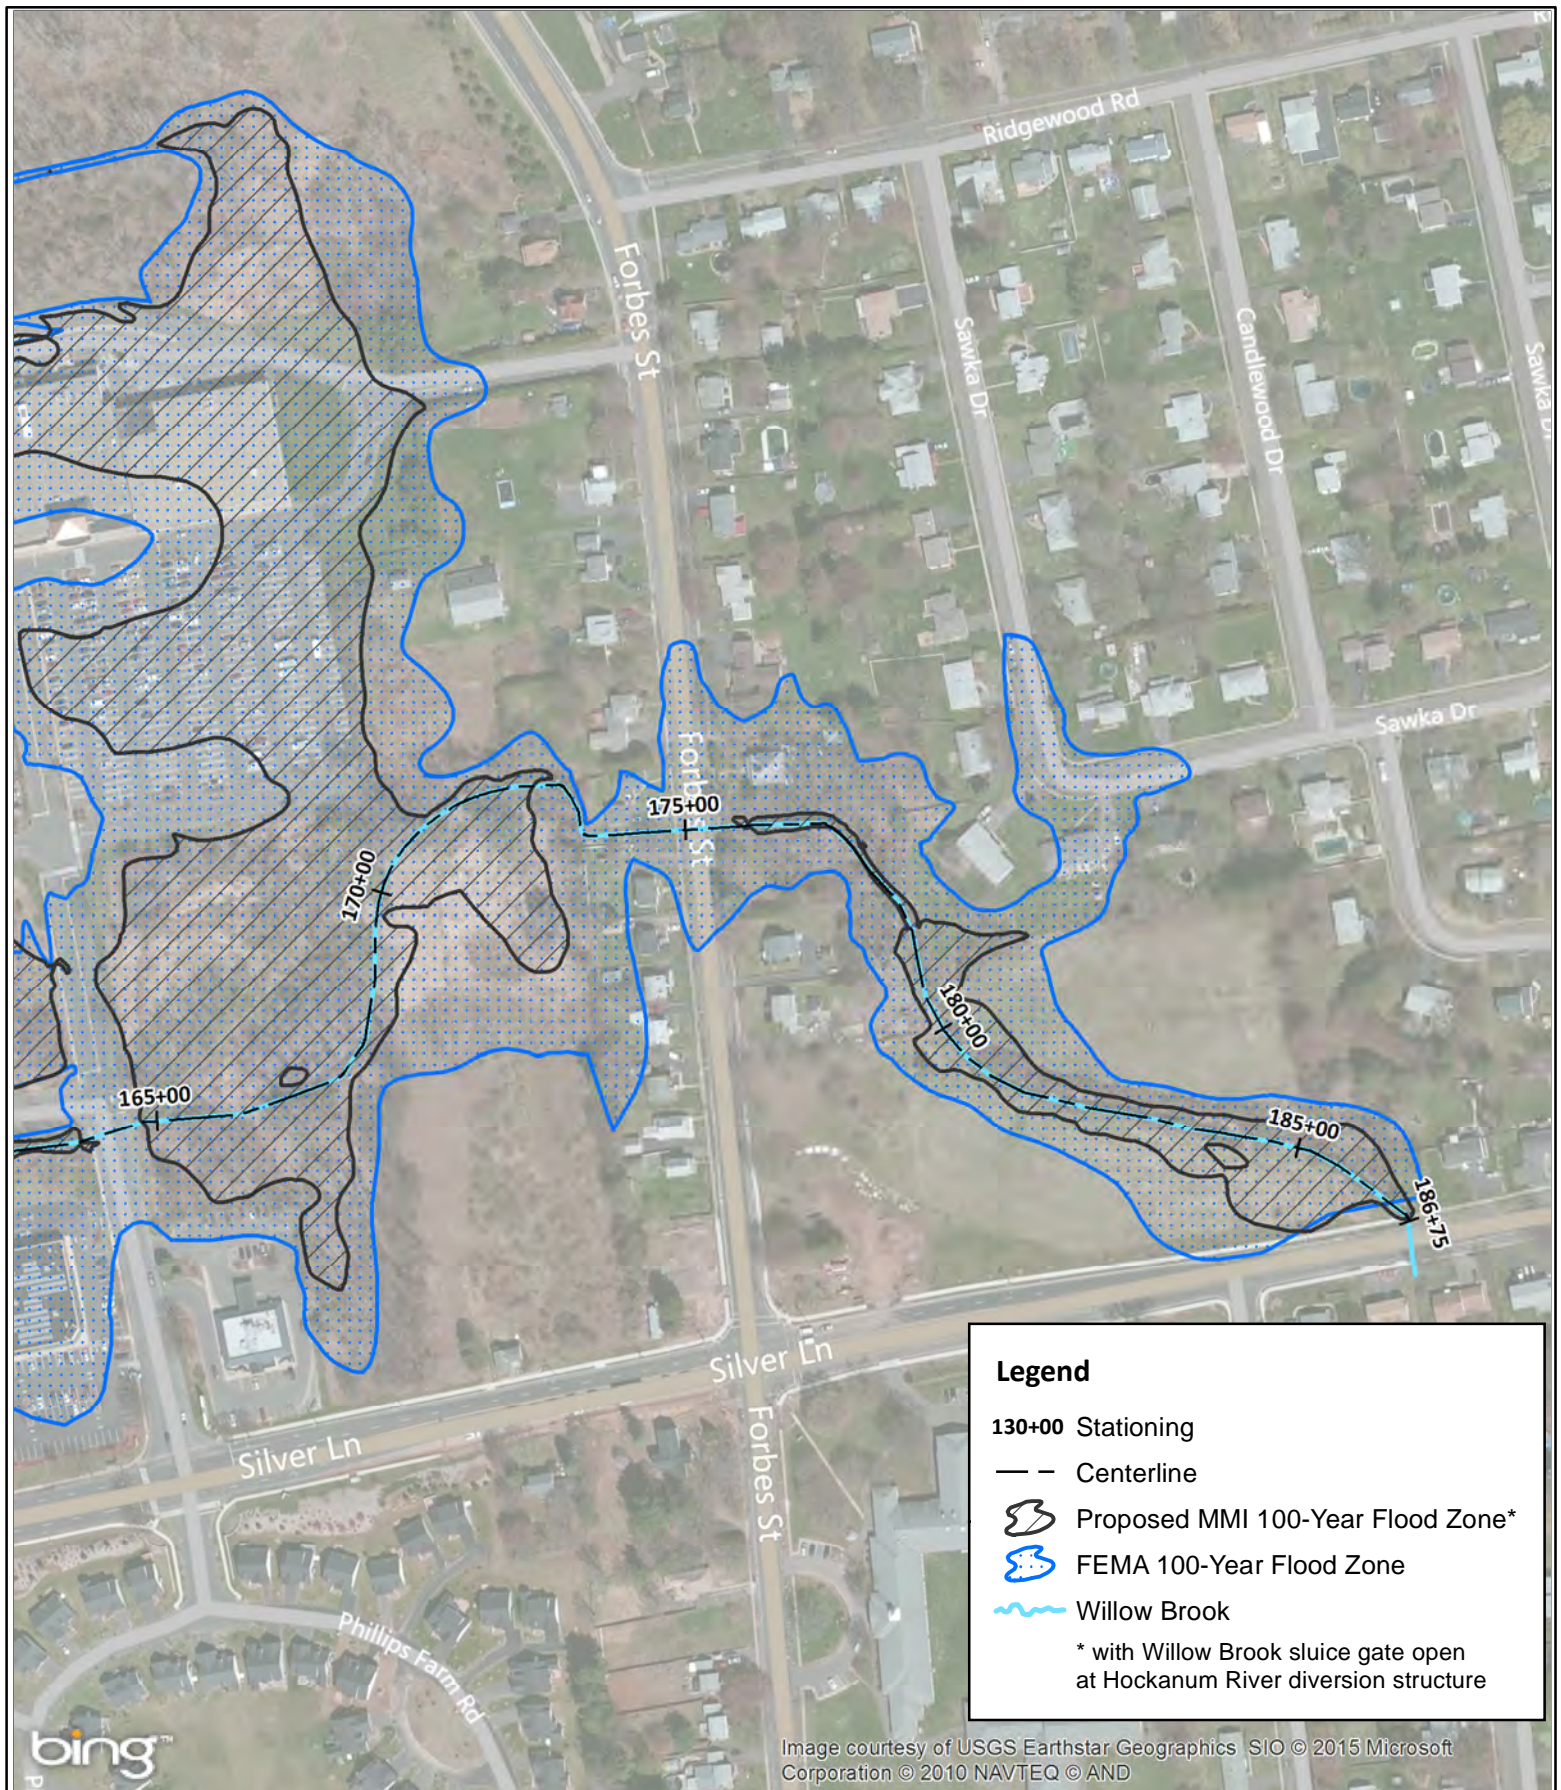
**Area 6: Proposed LOMR Updated Floodplain  
Mapping Upstream of Forbes Street**

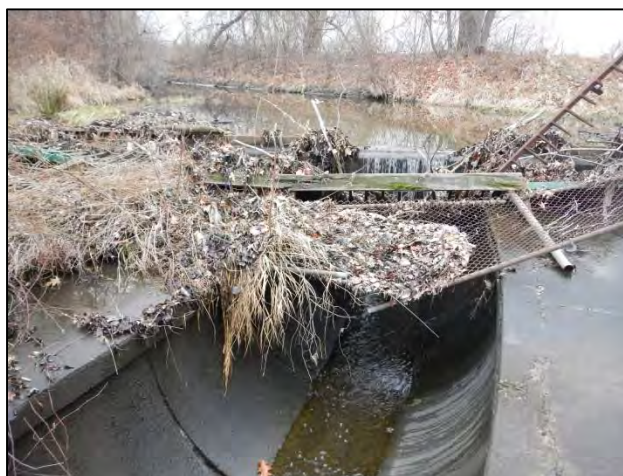
Debris accumulation can be influenced by a number of factors. A high source of debris such as unmanaged woods or a high rate of trash disposal in the system introduces debris to the channel. Areas of lower velocity tend to more readily accumulate debris. The adjacent photo shows debris accumulations at the Hockanum River diversion structure, which was constructed with chain link fencing and trash racks that have been damaged by debris during floods and have now failed. Woody debris has begun accumulating here and could impact the hydraulic performance, as well as further impact the structural stability of this structure.

**Photo: Debris Accumulation at the Hockanum River Diversion Structure**

Accumulations within the channel at many of the areas noted consist of large woody debris and trash that has been discarded into the brook. As debris settles and accumulates, it has the tendency to capture further debris that is mobilized during a high stream flows, so this condition can be expected to worsen over time. Debris can sometimes accumulate to a point at which it impedes or completely blocks flow, called a debris jamb.

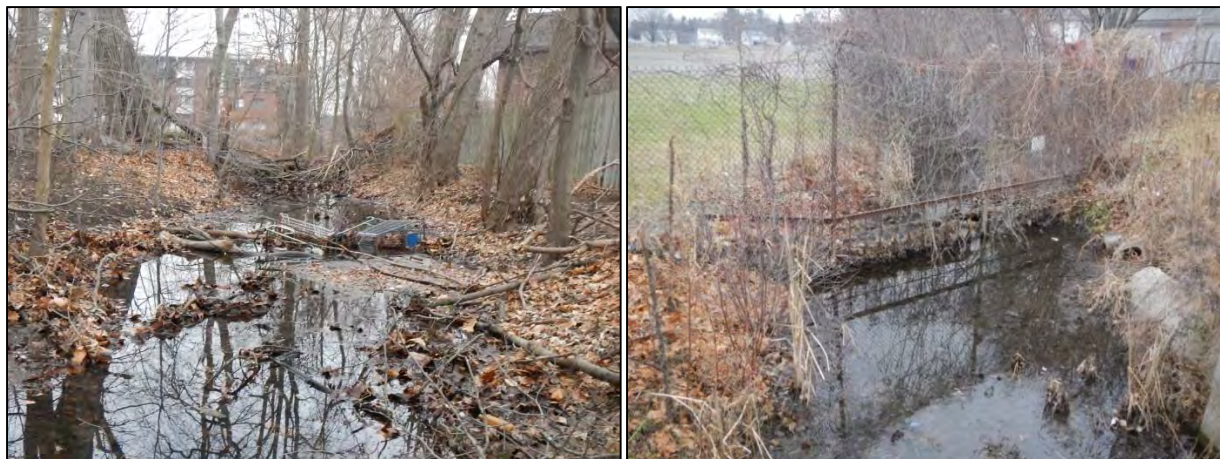
The photo on the left (below) presents an area near Silver Lane where a security fence constructed across the channel causes the accumulation of leaf litter and woody debris that has the effect of increasing backwater near homes along Simmons Road. The photo on the right shows an area near the end of the Gould Road cul-de-sac where litter, debris, wood, and trash has accumulated in the channel.

*Photo: Debris accumulation near Gould Drive (left) and Silver Lane (right)*

Management of debris may require the development of a long-term strategy and inspection schedule of those areas that are known to be debris-prone, as identified in Figure 5-26. While regulatory approval may be required at the local level, this type of work can be completed with hand tools and labor, such that disturbance to the channel should be minimal. If a debris management plan were developed and implemented, it may require Town of East Hartford resources to provide labor crews through Department of Public Works, or to contract labor for the removal and disposal of the debris on a semi-annual basis. Alternatively, volunteer interest could be coordinated via a “Brook Cleanup” initiative, which may be an effective and cost efficient way of removing debris in the channel.

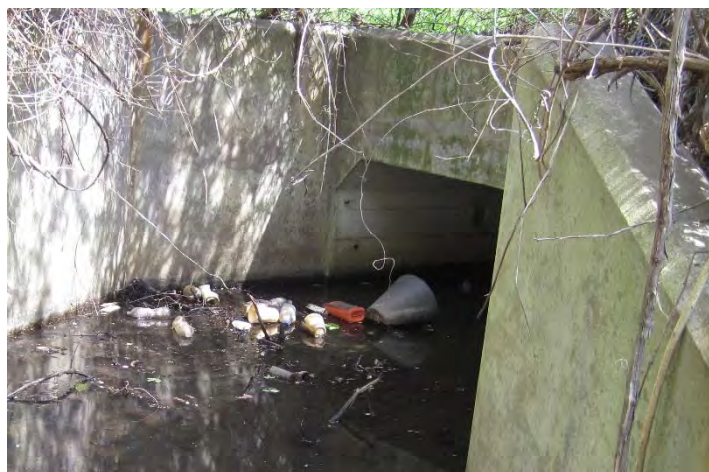
Cleanup work can be performed along the brook corridor to remove large woody debris and trash. This would require work crews to enter the brook, and manually remove the debris and trash.

*Debris and trash at various locations along Willow Brook*

WS-2 – Debris Removal			
<b>Priority</b> High	<b>Benefit</b> High: increase the water-carrying capacity of the channel.	<b>Cost</b> \$1k - \$10k at each location	<b>Timeframe</b> 3 to 6 Months
<b>Funding Eligibility</b> Town of East Hartford, Private	<b>Property Ownership</b> Town and Private	<b>Impacts</b> Wetland and stream channel vegetation and habitat through construction disturbance	<b>Permitting</b> Town of East Hartford

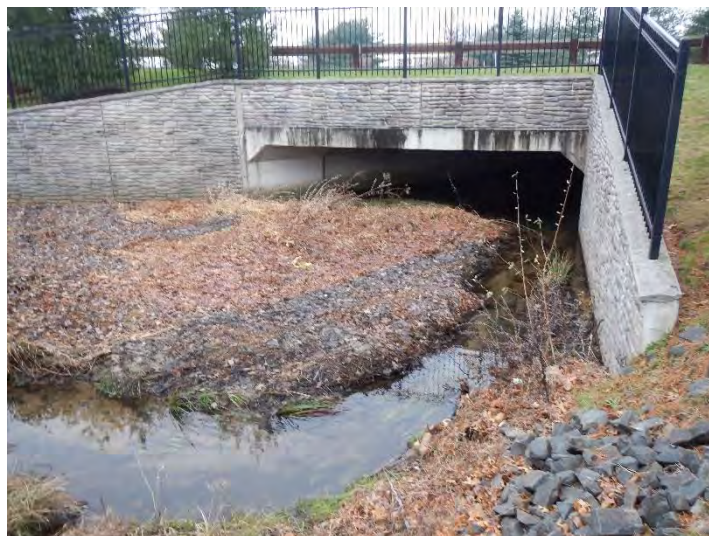
*Sediment accumulation upstream of East Hartford Boulevard North*

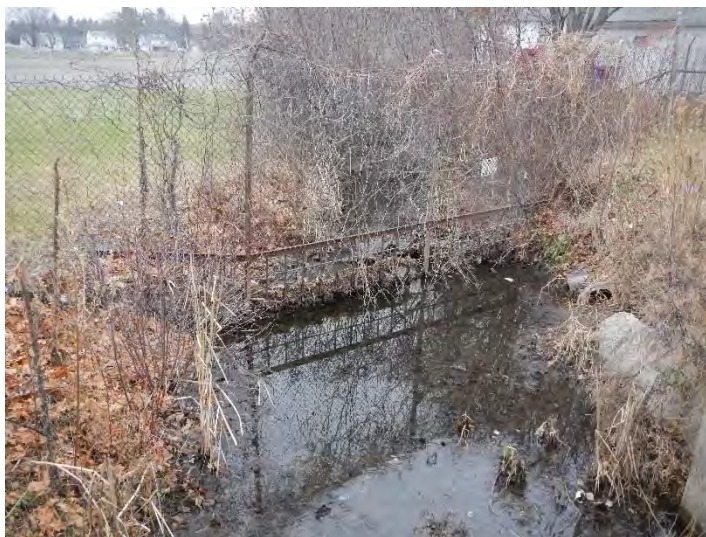
*Existing fence across channel collecting debris, upstream of Silver Lane*

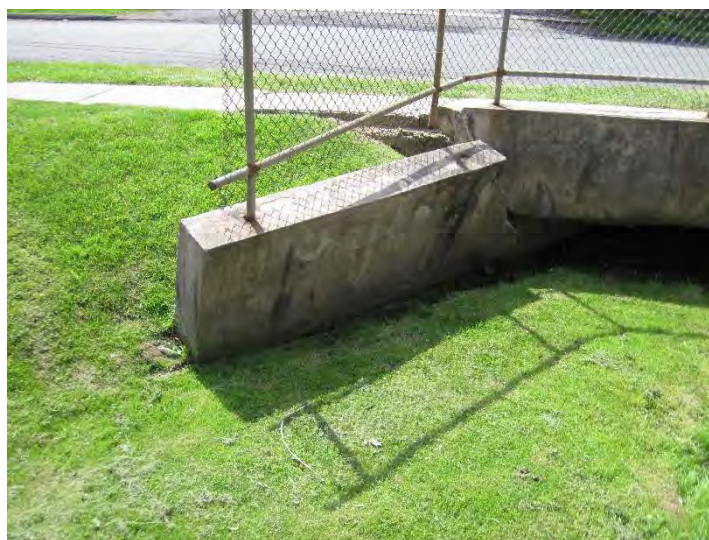
It is recommended that the headwalls and parapet of the Simmons Road culvert be removed and reconstructed. This would involve the design of cast-in-place concrete walls with footings sufficiently deep to prevent damage from frost or scour. The design and construction would likely be contracted out by the Town to a third party.

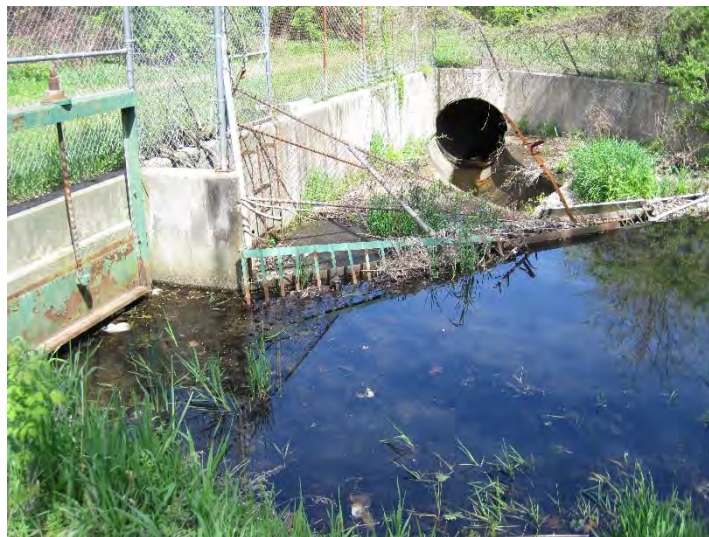
*Debris and structural failure of Hockanum River Diversion Structure*

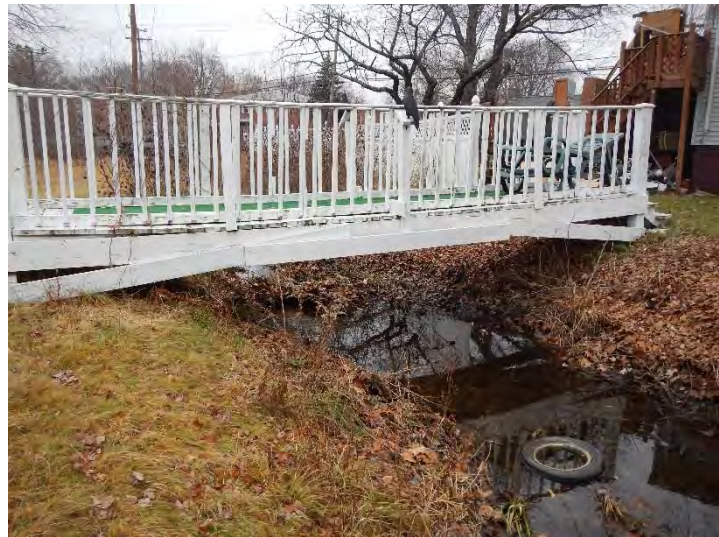
The backwater effects from an existing pedestrian bridge causes flooding upstream towards the Simmons Road area. The pedestrian bridge is located on private property approximately 200 feet downstream of the Simmons Road culvert. This structure was not modeled in the FEMA analysis, indicating that it may not have been present at the time the study was performed, but is located within the active floodway of the brook.

*Private pedestrian bridge*

2-2 – Remove Pedestrian Bridge and Widen Channel			
<b>Priority</b> High	<b>Benefit</b> High: Will remove flow restriction and increase hydraulic capacity of Willow Brook	<b>Cost</b> \$2k-\$5k	<b>Timeframe</b> 1 to 3 Months
<b>Funding Eligibility</b> Town of East Hartford, Private	<b>Property Ownership</b> Town and Private	<b>Impacts</b> Pedestrian accessibility	<b>Permitting</b> Town of East Hartford

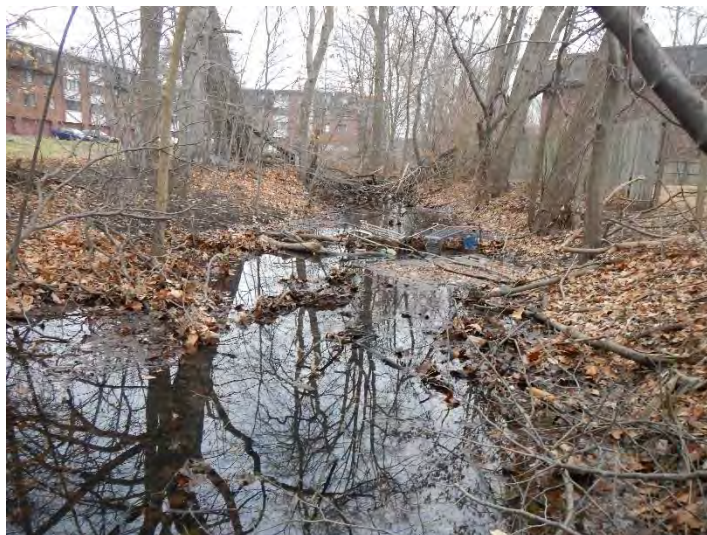
Sediment and debris have accumulated in the channel upstream of Cumberland Drive and Gould Drive. This reach of channel is relatively flat with shallow, slow-moving water. The floodplain is also very relatively flat and broad, where a minor increases in water surface elevation of a foot or two can cause water to leave the Willow Brook banks and flood onto the surrounding roadways.

*Sediment, debris, and trash accumulation near Gould Drive*

This alternative includes the removal of approximately 1.5 feet of material from the channel bed over a distance of approximately 900 feet. The estimated volume of sediment removal is approximately 1,600 cubic yards. The area in question crosses both public and private lands. This could be completed by Town crews with permission of the impacted private property owners.

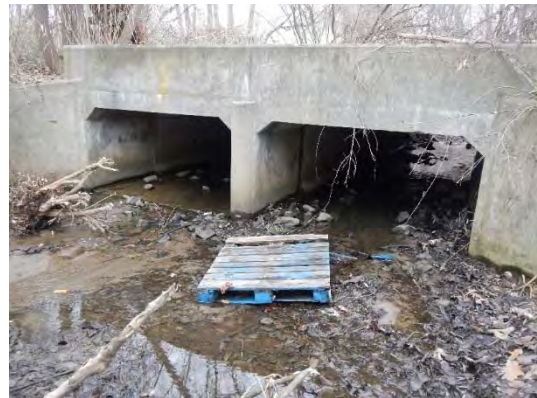
Alternative 4-2 recommends placement of fill to elevate the first floor elevation of a commercial structure in the floodplain, which causes a rise in flood elevations upstream. In order to help provide mitigation for the increase in flood elevations, removal of an abandoned bridge behind the plaza is also recommended. This would provide a benefit to upstream flood elevations and would offset the effects of raising the elevation of the plaza. This alternative would have all the same challenges as 4-2, but would the relatively minor cost of removing the abandoned bridge could mitigate some of the effects of the placement of fill within the floodplain, and present an alternative approach to achieving the same goal.

*Abandoned bridge*

<b>4-3 – Raise Elevation of Plaza &amp; Remove Abandoned Bridge</b>			
<b>Priority</b> Low	<b>Benefit</b> Medium: Benefits to redevelopment potential of one commercial property only	<b>Cost</b> >\$500k (Alt 4-2) \$5k-\$10k (bridge removal)	<b>Timeframe</b> 1 to 2 Years
<b>Funding Eligibility</b> Private	<b>Property Ownership</b> Private	<b>Impacts</b> Impacts to wetland, floodplain, and flooding on nearby properties.	<b>Permitting</b> FEMA, USACE State of CT DEEP, Town of East Hartford

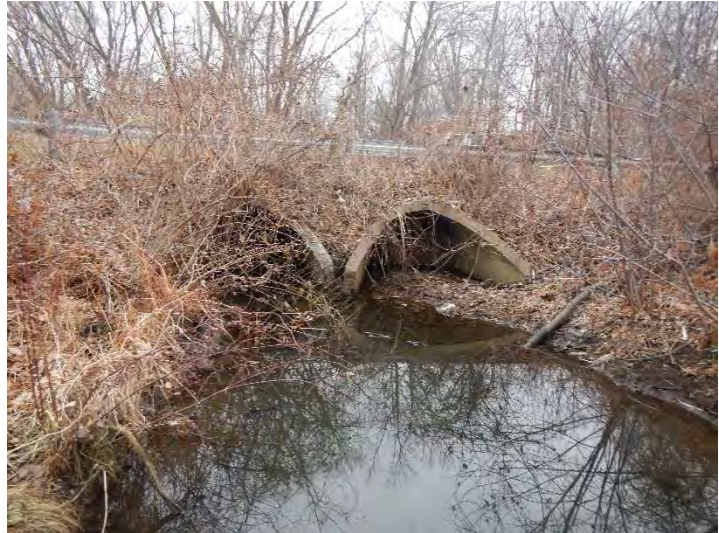
Replacement of the culverts beneath the Charter Oak Shopping Mall access road with a 16-foot by 5-foot box culvert provides flood relief to the plaza, and upstream properties. While predicted flooding of the Charter Oak Plaza could not be completely eliminated by upgrading the culvert alone, the depth of flooding predicted in the plaza is approximately one foot lower than predicted by FEMA, which may have an impact on the flood insurance rates paid by the owners of the property.

*Existing culverts beneath Charter Oak Shopping Mall Access Road*

Replacing the RCP culverts would provide a modest reduction in water surface elevations during the 100-year (1% ACR) flood by 1.4 feet. Figure 5-25 presents a profile view of the modeling results for the alternative.

5-2 – Upgrade Access Road Culvert			
<b>Priority</b> Medium	<b>Benefit</b> Medium: Reduce water surface elevations but does not eliminate flooding of Charter Oak Shopping Plaza	<b>Cost</b> \$250k – \$500k	<b>Timeframe</b> 1 to 2 Years
<b>Funding Eligibility</b> Private	<b>Property Ownership</b> Private	<b>Impacts</b> Wetland, stream channel, traffic and roadway, utilities	<b>Permitting</b> State of CT DEEP Town of East Hartford
